Intersection ID: 3299	Main Street: BRANTHURST_DR	Cross Street: SPRING_PARK_DR	Location:	N
ADA ID: 3795FCBC9F9D	Ramp Type: PerpDiag	Initial Pass/Fail: Fail	Overall Compliance: No	Severity Score: 36.25

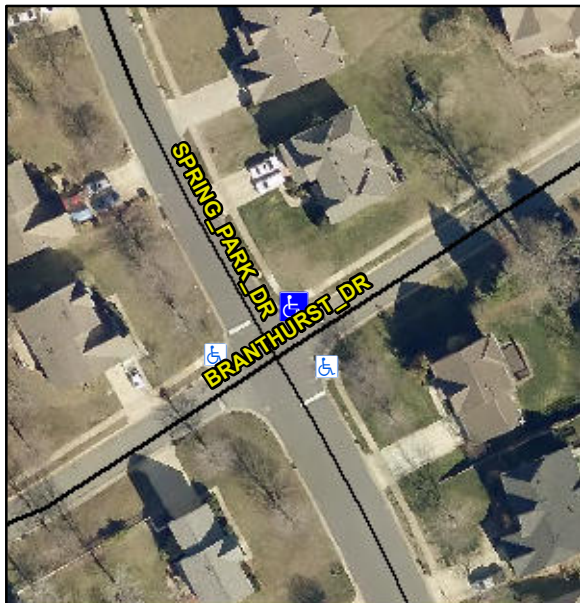
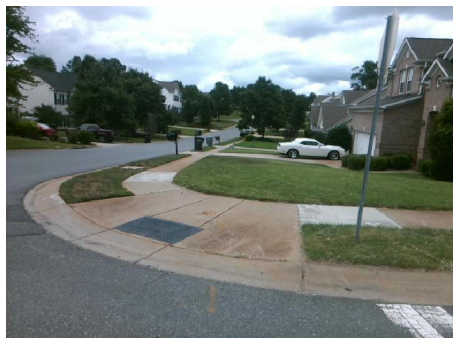
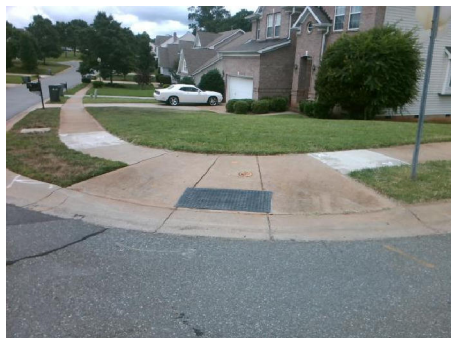
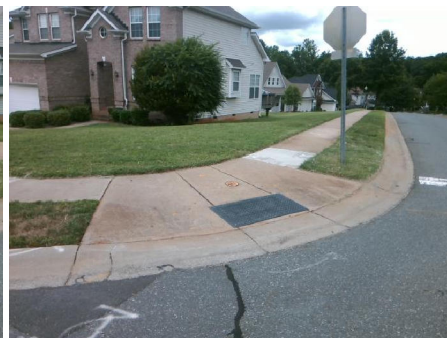
Possible Solutions:		Compliance	Description	Data	Compliance	Description	Data
	Remove & Replace Curb Ramp With Two New Directional Ramps or Equivalent.		N/A	Ramp Length (in)	95.0	Yes	Ramp Slope (%)	5.1
			No	Ramp Width (in)	26.0	No	Ramp XSlope (%)	4.6
			N/A	Flare Type LT	N/A	N/A	Flare Type RT	N/A
			N/A	Flare Slope LT (%)	N/A	N/A	Flare Slope RT (%)	N/A
			N/A	Flare Traversable LT?	N/A	N/A	Flare Traversable RT?	N/A
	Surveyor Notes:  N/A		N/A	Landing Length (in)	N/A	N/A	DWS Provided?	N/A
			N/A	Landing Width (in)	N/A	N/A	DWS Contrast?	N/A
			N/A	Landing Slope (%)	N/A	N/A	DWS Length (in)	N/A
			N/A	Landing X Slope (%)	N/A	N/A	DWS Full Width?	N/A
N/A			Landing Curb? (Y/N)	N/A	N/A	DWS Offset (in)	N/A	
PROW/ADA:  Not Found, R304.5.1, R304.5.3		N/A	Shared Landing?	N/A				
		N/A	Gutter Ponding?	N/A	N/A	Gutter Slope (%)	N/A

N/A	Gutter Lip Ht (in)	N/A	N/A	Gutter X Slope (%)	N/A	
		N/A	Painted X Walk1?	No	N/A	Painted X Walk2?	No	
			X Walk 1 Direction	To SW		X Walk 2 Direction	To SE	
		N/A	X Walk 1 Width (in)	N/A	N/A	X Walk 2 Width (in)	N/A	
			X Walk 1 Slope (%)	2.5		X Walk 2 Slope (%)	9.9	
			X Walk 1 X Slope (%)	6.8		X Walk 2 X Slope (%)	2.1	
		N/A	Ramp inside XWalk1?	N/A	N/A	Ramp inside XWalk2?	N/A	
			Road Slope (%)	2.9	N/A	Clear Space?	N/A	
			Road X Slope (%)	8.4	N/A	Clear Space to XWalk (in)	N/A	
		N/A	Any Obstructions?	N/A	N/A	Storm Grate/Utility Hazard?	N/A	
			Obstruction Type			Storm Grate/Utility Type		
					N/A		N/A	
						Yes	Surface Condition? (G/P)	Good
		Total Cost:	\$	3200.00
