# Access Compliance Report

## Public Rights-of-Way

### (Curb Ramps)

Intersection ID: 14069	Main Street: CLARICE_AV	Cross Street: E_8TH_ST	Location: E
ADA ID: 37A1BD21B174	Ramp Type: PerpDiag	Initial Pass/Fail: Fail	Overall Compliance: No
		Severity Score: 12.5

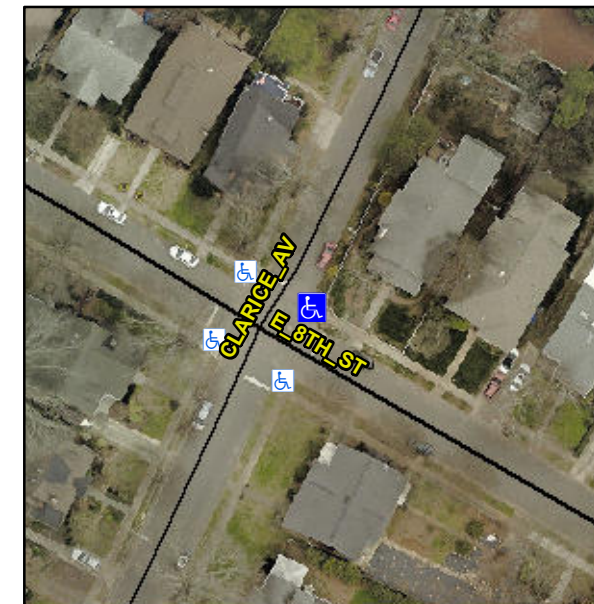
**Not Found, R304.2.2**

Compliance	Description	Data	Compliance	Description	Data
N/A	Ramp Length (in)	98.0	No	Ramp Slope (%)	9.2
Yes	Ramp Width (in)	48.0	Yes	Ramp XSlope (%)	1.8
N/A	Flare Type LT	N/A	N/A	Flare Type RT	N/A
N/A	Flare Slope LT (%)	N/A	N/A	Flare Slope RT (%)	N/A
N/A	Flare Traversable LT?	N/A	N/A	Flare Traversable RT?	N/A
N/A	Landing Length (in)	N/A	N/A	DWS Provided?	N/A
N/A	Landing Width (in)	N/A	N/A	DWS Contrast?	N/A
N/A	Landing Slope (%)	N/A	N/A	DWS Length (in)	N/A
N/A	Landing X Slope (%)	N/A	N/A	DWS Full Width?	N/A
N/A	Landing Curb? (Y/N)	N/A	N/A	DWS Offset (in)	N/A
N/A	Shared Landing?	N/A			
N/A	Gutter Ponding?	N/A	N/A	Gutter Slope (%)	N/A
N/A	Gutter Lip Ht (in)	N/A	N/A	Gutter X Slope (%)	N/A
N/A	Painted X Walk1?	No	N/A	Painted X Walk2?	No
	X Walk 1 Direction	To NW		X Walk 2 Direction	To SW
N/A	X Walk 1 Width (in)	N/A	N/A	X Walk 2 Width (in)	N/A
	X Walk 1 Slope (%)	1.4		X Walk 2 Slope (%)	2.8
	X Walk 1 X Slope (%)	2.2		X Walk 2 X Slope (%)	1.1

N/A	Ramp inside XWalk1?	N/A	N/A	Ramp inside XWalk2?	N/A
	Road Slope (%)	2.3	N/A	Clear Space?	N/A
	Road X Slope (%)	3.8	N/A	Clear Space to XWalk (in)	N/A
N/A	Any Obstructions?	N/A	N/A	Storm Grate/Utility Hazard?	N/A
	Obstruction Type			Storm Grate/Utility Type	
		N/A			N/A
			Yes	Surface Condition? (G/P)	Good

**Remove & Replace Curb Ramp With Two New Directional Ramps or Equivalent.**
