Access Compliance Report

Public Rights-of-Way

(Curb Ramps)

| Intersection ID: 12027 | Main Street: S_SUMMIT_AV | Cross Street: W_MOREHEAD_ST | Location: SE |

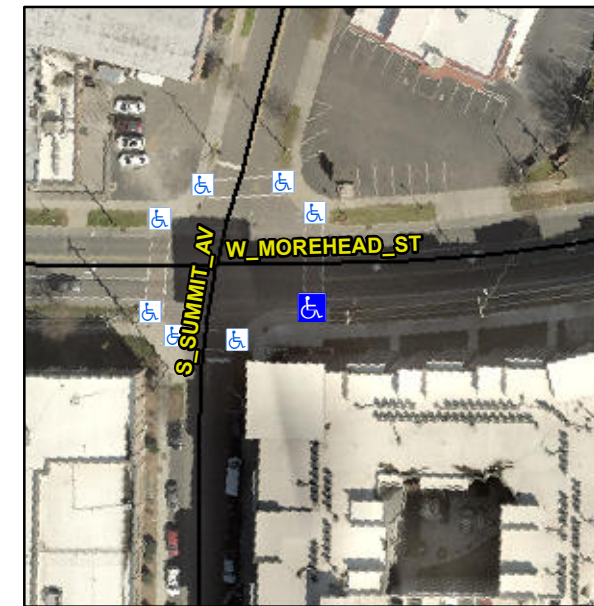
| ADA ID: 37A4BDE53019 | Ramp Type: Perp | Initial Pass/Fail: Fail | Overall Compliance: No |

Not Found, R304.5.1

| Compliance | Description | Data | Compliance | Description | Data |
|---|---|---|---|---|---|
| No | Ramp Width (in) | 47.5 | Yes | Ramp XSlope (%) | 0.6 |

Possible Solutions:

Remove & Replace Entire Ramp.
