Intersection ID: 15416	Main Street: COMMONWEALTH_AV	Cross Street: HIDDENBROOK_DR	Location:	SE
ADA ID: 37B27DB35FA0	Ramp Type: Combination1	Initial Pass/Fail: Fail	Overall Compliance: No	Severity Score: 58.75

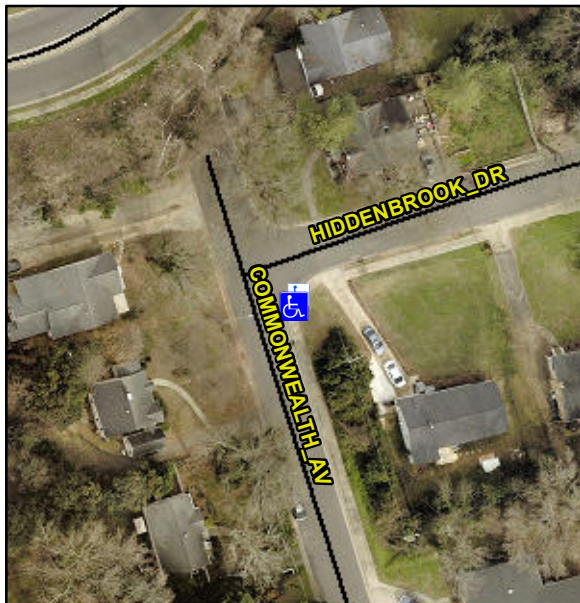
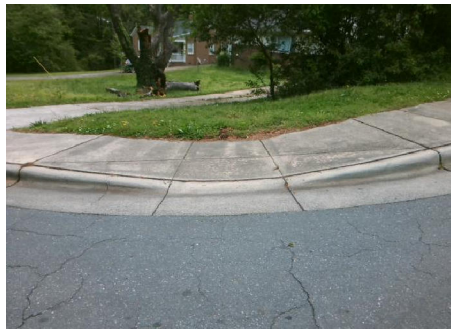
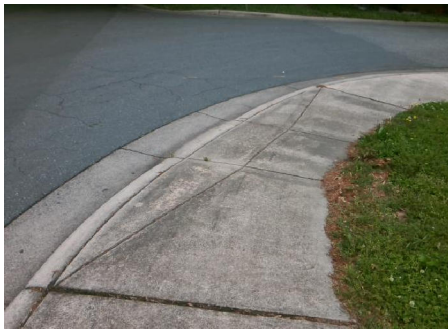
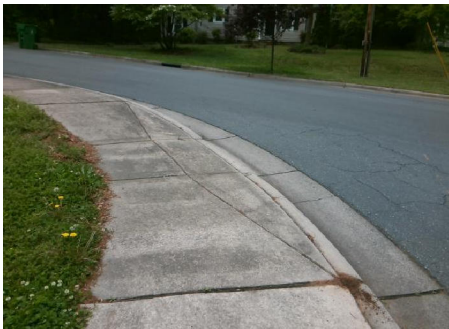
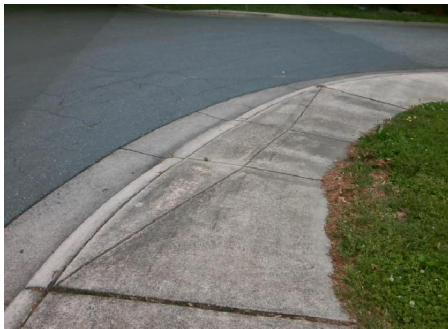
Possible Solutions:		Remove & Replace Entire Ramp.					
	Surveyor Notes:		LT RP < 5%					
	PROW/ADA:		Not Found, R304.5.1, R304.2.2, R304.5.3, R304.3.2					
	Street 1 Name		None					
	Stop Condition-Street 1		COMMONWEALTH AV					
	Street 2 Name		N/A					
	Stop Condition-Street 2		N/A					
	Total Cost:		\$ 1800.00

Compliance	Description	Data	Compliance	Description	Data
			N/A	Ramp Length LT (in)	61.0	N/A	Ramp Length RT (in)	64.0
			Yes	Ramp Width LT (in)	59.0	Yes	Ramp Width RT (in)	59.0
			Yes	Ramp Slope LT (%)	4.4	No	Ramp Slope RT (%)	14.1
			No	Ramp XSlope LT (%)	3.2	Yes	Ramp XSlope RT (%)	1.4
			N/A	Ramp Length (in)	59.0	No	Ramp Slope (%)	8.8
			No	Ramp Width (in)	38.0	No	Ramp XSlope (%)	9.5
			N/A	Flare Type LT	N/A	N/A	Flare Type RT	N/A
			N/A	Flare Slope LT (%)	N/A	N/A	Flare Slope RT (%)	N/A
			N/A	Flare Traversable LT?	N/A	N/A	Flare Traversable RT?	N/A
