# Access Compliance Report

## Public Rights-of-Way

### (Curb Ramps)

Intersection ID: 30468	Main Street: GOLDEN_VIEW_DR	Cross Street: OWLS_PERCH_DR	Location: NW
ADA ID: 37DA9BF7AC02	Ramp Type: PerpDiag	Initial Pass/Fail: Fail	Overall Compliance: No
Severity Score: 21.25			
Codes/Mitigation Info/Possible Solution		Field Measurements/Component Compliance

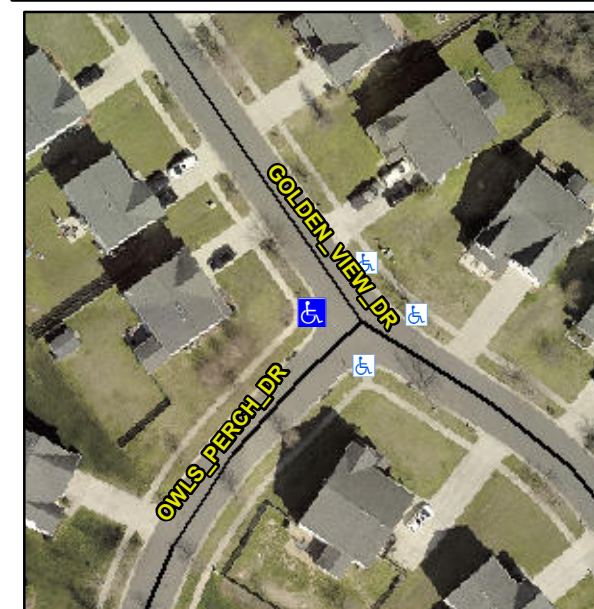
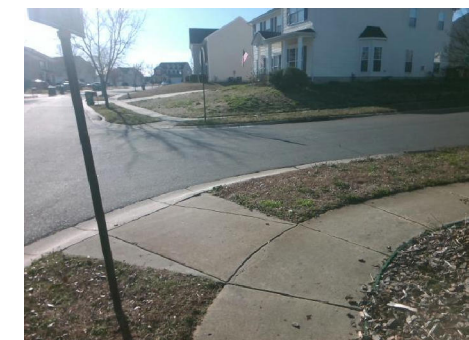
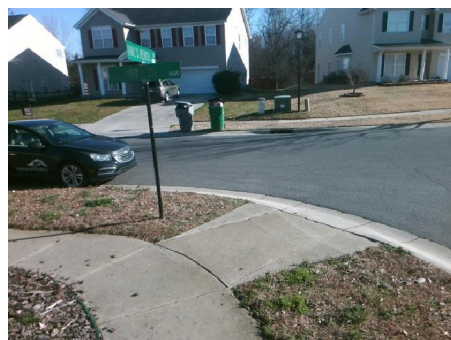
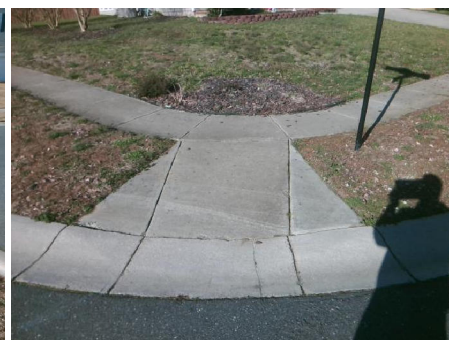
**Not Found, R304.5.1, R304.5.3**

Compliance	Description	Data	Compliance	Description	Data
N/A	Ramp Length (in)	83.0	Yes	Ramp Slope (%)	6.3
No	Ramp Width (in)	46.0	No	Ramp XSlope (%)	5.9
N/A	Flare Type LT	N/A	N/A	Flare Type RT	N/A
N/A	Flare Slope LT (%)	N/A	N/A	Flare Slope RT (%)	N/A
N/A	Flare Traversable LT?	N/A	N/A	Flare Traversable RT?	N/A
N/A	Landing Length (in)	N/A	N/A	DWS Provided?	N/A
N/A	Landing Width (in)	N/A	N/A	DWS Contrast?	N/A
N/A	Landing Slope (%)	N/A	N/A	DWS Length (in)	N/A
N/A	Landing X Slope (%)	N/A	N/A	DWS Full Width?	N/A
N/A	Landing Curb? (Y/N)	N/A	N/A	DWS Offset (in)	N/A
N/A	Shared Landing?	N/A			
N/A	Gutter Ponding?	N/A	N/A	Gutter Slope (%)	N/A
N/A	Gutter Lip Ht (in)	N/A	N/A	Gutter X Slope (%)	N/A
N/A	Painted X Walk1?	No	N/A	Painted X Walk2?	No
	X Walk 1 Direction	To SE		X Walk 2 Direction	To NE
N/A	X Walk 1 Width (in)	N/A	N/A	X Walk 2 Width (in)	N/A
	X Walk 1 Slope (%)	0.5		X Walk 2 Slope (%)	1.1
	X Walk 1 X Slope (%)	2.4		X Walk 2 X Slope (%)	3.4

N/A	Ramp inside XWalk1?	N/A	N/A	Ramp inside XWalk2?	N/A
	Road Slope (%)	2.2	N/A	Clear Space?	N/A
	Road X Slope (%)	0.4	N/A	Clear Space to XWalk (in)	N/A
N/A	Any Obstructions?	N/A	N/A	Storm Grate/Utility Hazard?	N/A
	Obstruction Type			Storm Grate/Utility Type	
		N/A			N/A
			Yes	Surface Condition? (G/P)	Good

**Remove & Replace Curb Ramp With Two New Directional Ramps or Equivalent.**

Total Cost: \$ 3200.00
