# Access Compliance Report

## Public Rights-of-Way

### (Curb Ramps)

Intersection ID: 23977		Main Street: REA_RD		Cross Street: WINDYRUSH_RD		Location: SE											
ADA ID: 37E787DA2FC5		Ramp Type: Directional1		Initial Pass/Fail: Fail		Overall Compliance: No		Severity Score: 1.25									
Codes/Mitigation Info/Possible Solution				Field Measurements/Component Compliance													
<div>

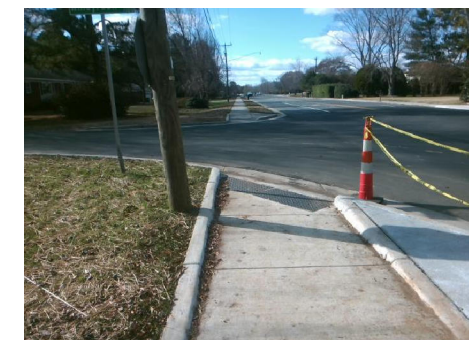
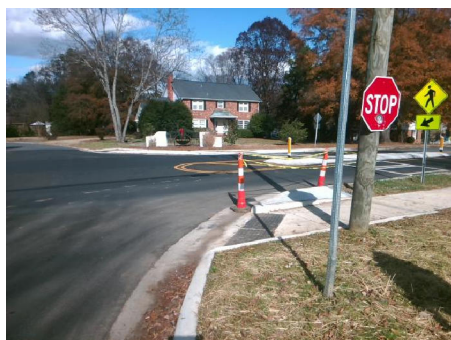
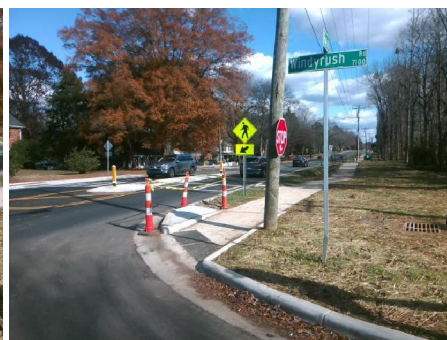
No		Ramp XSlope (%)		2.6									
				N/A		Flare Type LT		N/A		N/A		Flare Type RT		N/A			
				N/A		Flare Slope LT (%)		N/A		N/A		Flare Slope RT (%)		0.0			
				N/A		Flare Traversable LT?		N/A		N/A		Flare Traversable RT?		N/A			
				N/A		Landing Length (in)		0.0		N/A		DWS Provided?		N/A			
				N/A		Landing Width (in)		0.0		N/A		DWS Contrast?		N/A			
				N/A		Landing Slope (%)		0.0		N/A		DWS Length (in)		N/A			
				N/A		Landing X Slope (%)		0.0		N/A		DWS Full Width?		N/A			
				N/A		Landing Curb? (Y/N)		N/A		N/A		DWS Offset LT (in)		N/A			
				N/A		Shared Landing?		N/A		N/A		DWS Offset RT (in)		N/A			
				N/A		Gutter Ponding?		0.0		N/A		Gutter Slope (%)		N/A			
				N/A		Gutter Lip Ht (in)		0.0		N/A		Gutter X Slope (%)		N/A			
				N/A		Painted X Walk1?		No				Road Slope (%)		1.0			
						X Walk 1 Direction		To W				Road X Slope (%)		0.5			
						X Walk 1 Width (in)		N/A				Clear Space?		N/A			
						X Walk 1 Slope (%)		1.0		N/A		Clear Space to XWalk (in)		N/A

X Walk 1 X Slope (%)		0.5		N/A		Storm Grate/Utility Hazard?		N/A			
				N/A		Ramp inside XWalk1?		N/A				Storm Grate/Utility Type					
				N/A		Any Obstructions?		N/A						N/A			
						Obstruction Type				Yes		Surface Condition? (G/P)		Good			
										N/A		N/A		Curb Slope (%)		9.1

</div> <div>Possible Solutions: <b>Remove &amp; Replace Entire Ramp.</b></div> <div>Surveyor Notes: <b>N/A</b></div> <div>PROW/ADA: <b>R304.5.3</b></div> <div>Street 1 Name <b>WINDYRUSH RD</b></div> <div>Stop Condition-Street 1 <b>StopSign</b></div> <div>Street 2 Name <b>N/A</b></div> <div>Stop Condition-Street 2 <b>N/A</b></div> <div>Total Cost: <b>\$ 1600.00</b></div>				Compliance		Description		Data		Compliance		Description		Data			
				N/A		Ramp Length (in)		32.0		N/A		Grade Break?		N/A			
				Yes		Ramp Width (in)		68.0		N/A		Grade Break Slope (%)		0.0			
				Yes		Ramp Slope (%)		2.6		N/A		Grade Break XSlope (%)		0.0
