# Access Compliance Report

## Public Rights-of-Way

### (Curb Ramps)

Intersection ID: 31717	Main Street: MOSSYCUP_DR	Cross Street: PLOWDON_CT	Location: SW
ADA ID: 37E9895A2FFC	Ramp Type: PerpDiag	Initial Pass/Fail: Fail	Overall Compliance: No
Severity Score: 37.5			
Codes/Mitigation Info/Possible Solution		Field Measurements/Component Compliance

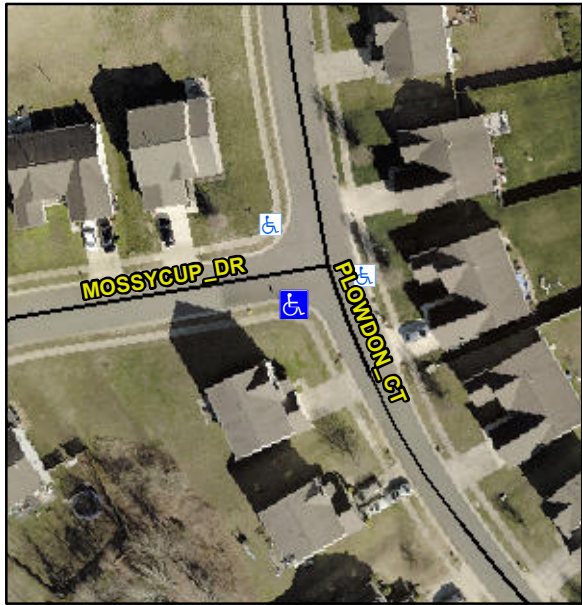
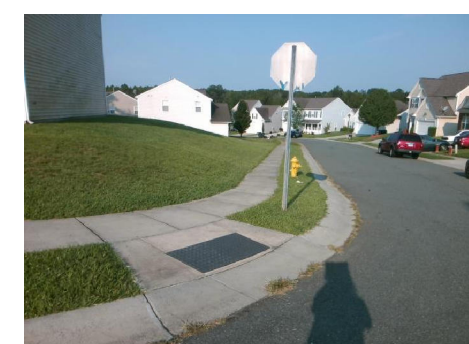
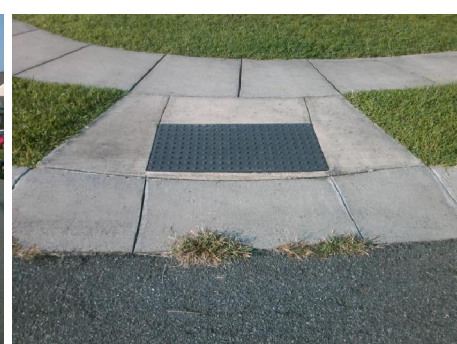
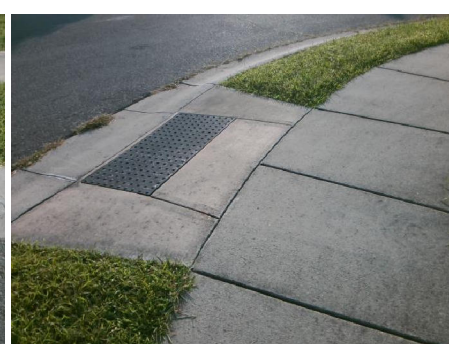
<b>N/A</b>	Landing Slope (%)	<b>N/A</b>	<b>N/A</b>	DWS Length (in)	<b>N/A</b>	
		<b>N/A</b>	Landing X Slope (%)	<b>N/A</b>	<b>N/A</b>	DWS Full Width?	<b>N/A</b>	
		<b>N/A</b>	Landing Curb? (Y/N)	<b>N/A</b>	<b>N/A</b>	DWS Offset (in)	<b>N/A</b>	
		<b>N/A</b>	Shared Landing?	<b>N/A</b>				
		<b>N/A</b>	Gutter Ponding?	<b>N/A</b>	<b>N/A</b>	Gutter Slope (%)	<b>N/A</b>	
		<b>N/A</b>	Gutter Lip Ht (in)	<b>N/A</b>	<b>N/A</b>	Gutter X Slope (%)	<b>N/A</b>	
		<b>N/A</b>	Painted X Walk1?	<b>No</b>	<b>N/A</b>	Painted X Walk2?	<b>No</b>	
			X Walk 1 Direction	<b>To E</b>		X Walk 2 Direction	<b>To N</b>	
		<b>N/A</b>	X Walk 1 Width (in)	<b>N/A</b>	<b>N/A</b>	X Walk 2 Width (in)	<b>N/A</b>	
			X Walk 1 Slope (%)	<b>5.3</b>		X Walk 2 Slope (%)	<b>0.1</b>	
			X Walk 1 X Slope (%)	<b>5.9</b>		X Walk 2 X Slope (%)	<b>6.8</b>	
		<b>N/A</b>	Ramp inside XWalk1?	<b>N/A</b>	<b>N/A</b>	Ramp inside XWalk2?	<b>N/A</b>	
			Road Slope (%)	<b>7.7</b>	<b>N/A</b>	Clear Space?	<b>N/A</b>

Road X Slope (%)	<b>1.2</b>	<b>N/A</b>	Clear Space to XWalk (in)	<b>N/A</b>	
		<b>N/A</b>	Any Obstructions?	<b>N/A</b>	<b>N/A</b>	Storm Grate/Utility Hazard?	<b>N/A</b>	
			Obstruction Type			Storm Grate/Utility Type		
				<b>N/A</b>			<b>N/A</b>	
					<b>Yes</b>	Surface Condition? (G/P)	<b>Good</b>	
Total Cost:		<b>\$</b>	<b>3200.00</b>

Possible Solutions:							
	<b>Remove &amp; Replace Curb Ramp With Two New Directional Ramps or Equivalent.</b>							
	Surveyor Notes:							
	<b>N/A</b>							
	PROW/ADA:							
	<b>Not Found, R304.2.2, R304.5.3</b>							
	Street 1 Name	<b>PLOWDON CT</b>	Compliance	Description	Data	Compliance	Description	Data
	Stop Condition-Street 2	<b>None</b>	<b>N/A</b>	Ramp Length (in)	<b>47.0</b>	<b>No</b>	Ramp Slope (%)	<b>10.6</b>
	Street 2 Name	<b>MOSSYCUP DR</b>	<b>Yes</b>	Ramp Width (in)	<b>48.0</b>	<b>No</b>	Ramp XSlope (%)	<b>8.1</b>
	Stop Condition-Street 1	<b>StopSign</b>	<b>N/A</b>	Flare Type LT	<b>N/A</b>	<b>N/A</b>	Flare Type RT	<b>N/A</b>
		<b>N/A</b>	Flare Slope LT (%)	<b>N/A</b>	<b>N/A</b>	Flare Slope RT (%)	<b>N/A</b>	
		<b>N/A</b>	Flare Traversable LT?	<b>N/A</b>	<b>N/A</b>	Flare Traversable RT?	<b>N/A</b>	
		<b>N/A</b>	Landing Length (in)	<b>N/A</b>	<b>N/A</b>	DWS Provided?	<b>N/A</b>	
		<b>N/A</b>	Landing Width (in)	<b>N/A</b>	<b>N/A</b>	DWS Contrast?	<b>N/A</b>
