# Access Compliance Report

## Public Rights-of-Way

### (Curb Ramps)

Intersection ID: 20640	Main Street: S_TRYON_ST	Cross Street: YAGER_CREEK_DR	Location: E
ADA ID: 37F1B09C93E7	Ramp Type: Perp	Initial Pass/Fail: Fail	Overall Compliance: No
Codes/Mitigation Info/Possible Solution		Field Measurements/Component Compliance	
Severity Score: 21.25

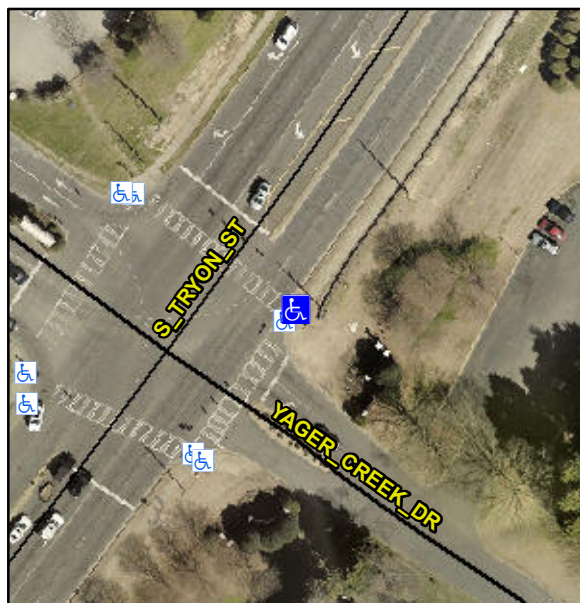
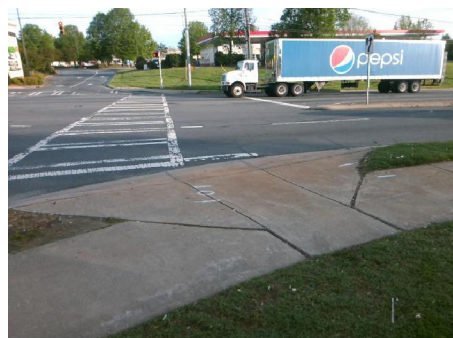
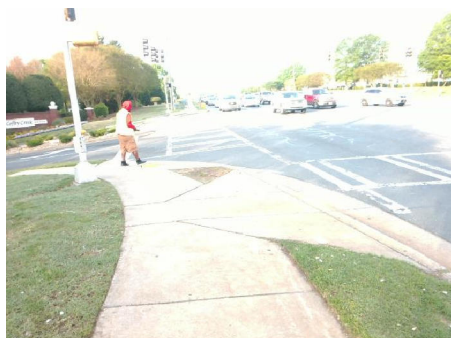
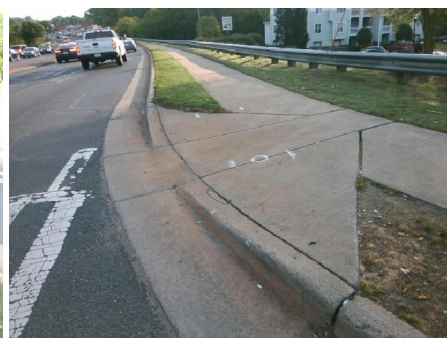
**Not Found, R304.5.1, R304.2.2**

Compliance	Description	Data	Compliance	Description	Data
N/A	Ramp Length (in)	77.0	No	Ramp Slope (%)	8.6
No	Ramp Width (in)	45.0	Yes	Ramp XSlope (%)	1.1
N/A	Flare Type LT	N/A	N/A	Flare Type RT	N/A
N/A	Flare Slope LT (%)	N/A	N/A	Flare Slope RT (%)	N/A
N/A	Flare Traversable LT?	N/A	N/A	Flare Traversable RT?	N/A
N/A	Landing Length (in)	N/A	N/A	DWS Provided?	N/A
N/A	Landing Width (in)	N/A	N/A	DWS Contrast?	N/A
N/A	Landing Slope (%)	N/A	N/A	DWS Length (in)	N/A
N/A	Landing X Slope (%)	N/A	N/A	DWS Full Width?	N/A
N/A	Landing Curb? (Y/N)	N/A	N/A	DWS Offset (in)	N/A
N/A	Shared Landing?	N/A			
N/A	Gutter Ponding?	N/A	N/A	Gutter Slope (%)	N/A
N/A	Gutter Lip Ht (in)	N/A	N/A	Gutter X Slope (%)	N/A
N/A	Painted X Walk1?	Yes	N/A	Painted X Walk2?	N/A
	X Walk 1 Direction	To NW		X Walk 2 Direction	N/A
N/A	X Walk 1 Width (in)	97.0	N/A	X Walk 2 Width (in)	N/A
	X Walk 1 Slope (%)	0.7		X Walk 2 Slope (%)	N/A
	X Walk 1 X Slope (%)	0.9		X Walk 2 X Slope (%)	N/A

N/A	Ramp inside XWalk1?	No	N/A	Ramp inside XWalk2?	N/A
	Road Slope (%)	N/A	N/A	Clear Space?	N/A
	Road X Slope (%)	N/A	N/A	Clear Space to XWalk (in)	N/A
N/A	Any Obstructions?	N/A	N/A	Storm Grate/Utility Hazard?	N/A
	Obstruction Type			Storm Grate/Utility Type	
		N/A			N/A
		Yes		Surface Condition? (G/P)	Good

**Remove & Replace Entire Ramp.  
Restripe Crosswalk.**
