Access Compliance Report

Public Rights-of-Way

(Curb Ramps)

Intersection ID: 14918	Main Street: KENILWORTH_AV	Cross Street: PIERCE_ST	Location:	E
ADA ID: 37FC78EE94DA	Ramp Type: Directional1	Initial Pass/Fail: Fail	Overall Compliance: No	Severity Score: 1.25

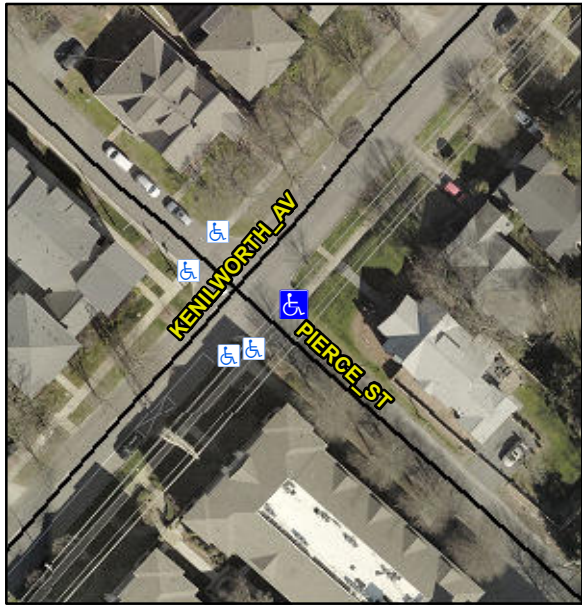
Possible Solutions:		Compliance			Description			Data	
	Remove & Replace Entire Ramp.		N/A	Ramp Length (in)	26.0	N/A	Grade Break?	N/A		
			Yes	Ramp Width (in)	48.0	N/A	Grade Break Slope (%)	0.0		
			Yes	Ramp Slope (%)	0.3	N/A	Grade Break XSlope (%)	0.0		
			No	Ramp XSlope (%)	4.3					
			N/A	Flare Type LT	N/A	N/A	Flare Type RT	N/A		
			N/A	Flare Slope LT (%)	N/A	N/A	Flare Slope RT (%)	0.0		
			N/A	Flare Traversable LT?	N/A	N/A	Flare Traversable RT?	N/A		
			N/A	Landing Length (in)	0.0	N/A	DWS Provided?	N/A		
			N/A	Landing Width (in)	0.0	N/A	DWS Contrast?	N/A		
Surveyor Notes:		N/A	N/A	Landing Slope (%)	0.0	N/A	DWS Length (in)	N/A		
		N/A	N/A	Landing X Slope (%)	0.0	N/A	DWS Full Width?	N/A		
PROW/ADA:		R304.5.3	N/A	Landing Curb? (Y/N)	N/A	N/A	DWS Offset LT (in)	N/A		
			N/A	Shared Landing?	N/A	N/A	DWS Offset RT (in)	N/A

N/A	Gutter Ponding?	0.0	N/A	Gutter Slope (%)	N/A		
			N/A	Gutter Lip Ht (in)	0.0	N/A	Gutter X Slope (%)	N/A		
			N/A	Painted X Walk1?	No		Road Slope (%)	5.4		
				X Walk 1 Direction	To SW		Road X Slope (%)	1.5		
				X Walk 1 Width (in)	N/A		Clear Space?	N/A		
				X Walk 1 Slope (%)	5.4	N/A	Clear Space to XWalk (in)	N/A		
				X Walk 1 X Slope (%)	1.5	N/A	Storm Grate/Utility Hazard?	N/A		
			N/A	Ramp inside XWalk1?	N/A		Storm Grate/Utility Type			
			N/A	Any Obstructions?	N/A			N/A		
				Obstruction Type		Yes	Surface Condition? (G/P)	Good		
						N/A	Curb Slope (%)	8.5		
Street 1 Name		PIERCE ST								
Stop Condition-Street 1		StopSign								
Street 2 Name		N/A								
Stop Condition-Street 2		N/A								
Total Cost:			\$	1600.00
