Access Compliance Report

Public Rights-of-Way

(Curb Ramps)

Intersection ID: 12493	Main Street: BELVEDERE_AV	Cross Street: WINTER_ST	Location: SE
ADA ID: 380225964CAF	Ramp Type: BlendTrans1	Initial Pass/Fail: Fail	Overall Compliance: No
		Severity Score: 1.25

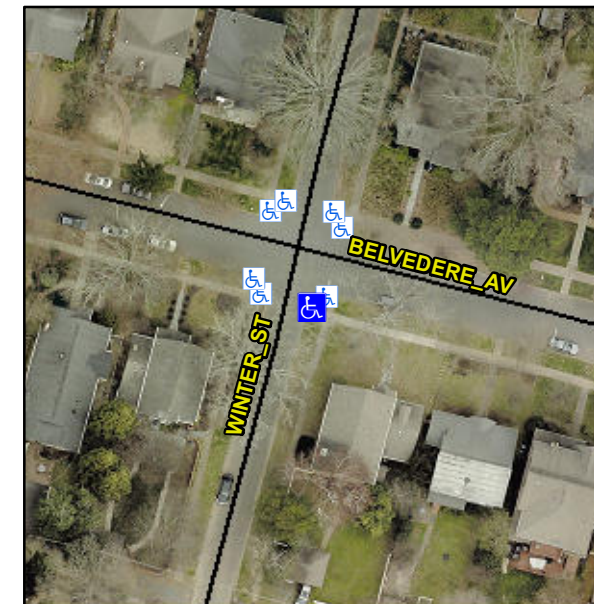
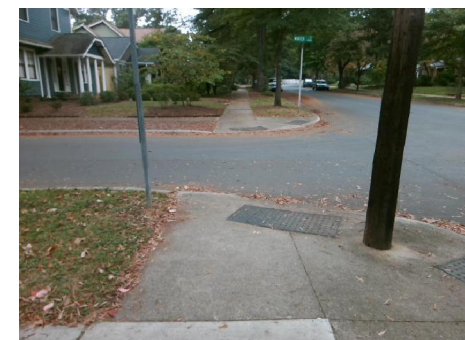
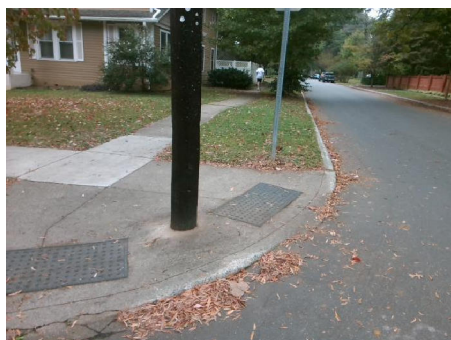
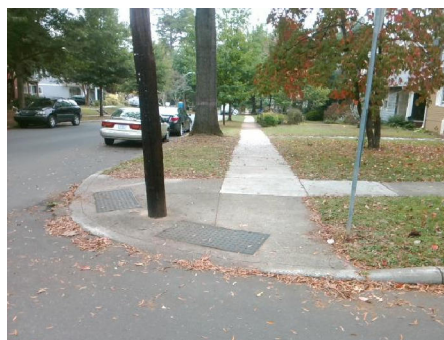
UTLITY POLE LT FL, FAILED INITIAL VALIDATION

R304.5.3

Compliance	Description	Data	Compliance	Description	Data
N/A	Ramp Length (in)	84.5	Yes	BlendTrans Slope (%)	0.9
Yes	Ramp Width (in)	52.0	No	BlendTrans XSlope (%)	2.5
N/A	Flare Type LT	N/A	N/A	Flare Type RT	N/A
N/A	Flare Slope LT (%)	N/A	N/A	Flare Slope RT (%)	N/A
N/A	Flare Traversable LT?	N/A	N/A	Flare Traversable RT?	N/A
N/A	Landing Length (in)	N/A	N/A	DWS Provided?	N/A
N/A	Landing Width (in)	N/A	N/A	DWS Contrast?	N/A
N/A	Landing Slope (%)	N/A	N/A	DWS Length (in)	N/A
N/A	Landing X Slope (%)	N/A	N/A	DWS Full Width?	N/A
N/A	Landing Curb? (Y/N)	N/A	N/A	DWS Offset (in)	N/A
N/A	Shared Landing?	N/A			
N/A	Gutter Ponding?	N/A	N/A	Gutter Slope (%)	N/A
N/A	Gutter Lip Ht (in)	N/A	N/A	Gutter X Slope (%)	N/A
N/A	Painted X Walk1?	No	N/A	Painted X Walk2?	N/A
	X Walk 1 Direction	To W		X Walk 2 Direction	N/A
	X Walk 1 Width (in)	N/A		X Walk 2 Width (in)	N/A
	X Walk 1 Slope (%)	4.4		X Walk 2 Slope (%)	N/A
	X Walk 1 X Slope (%)	1.0		X Walk 2 X Slope (%)	N/A

Remove & Replace Curb Ramp With Two New Directional Ramps or Equivalent.
