Access Compliance Report

Public Rights-of-Way

(Curb Ramps)

| Intersection ID: N/A | Main Street: STEELE_CREEK_RD | Cross Street: N/A | Location: SW |

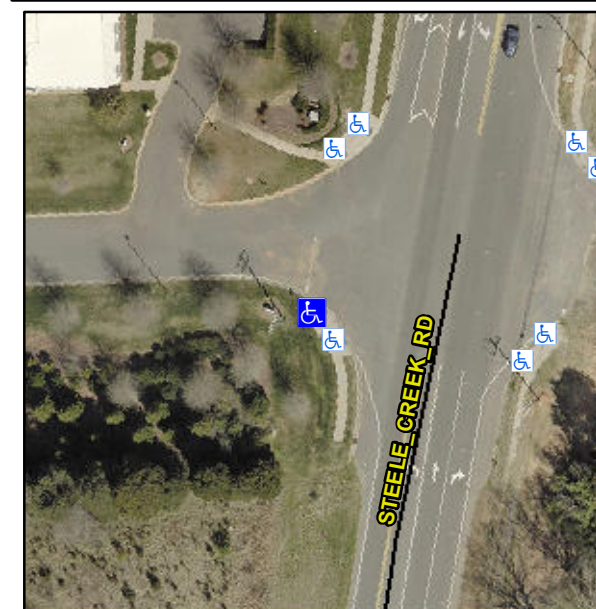
| ADA ID: 38041E7634E5 | Ramp Type: Perp | Initial Pass/Fail: Fail | Overall Compliance: No |
| Severity Score: 12.5 | | | |

Not Found, R304.2.2

| Compliance | Description | Data | Compliance | Description | Data |
|---|---|---|---|---|---|
| N/A | Ramp Length (in) | 59.0 | No | Ramp Slope (%) | 8.7 |

Possible Solutions:

Remove & Replace Entire Ramp.

Total Cost: \$ 1850.00
