Access Compliance Report Public Rights-of-Way (Curb Ramps)

Interpretion ID: 12600	Main St		OD OT	Croco	Street				Loostion	E
Intersection ID: 13600	Main Street: 3RD-4TH_CONNECTOR_ST			Cross	Street:	E_4TH_ST	Location:	E		
ADA ID: 382915EB96F2	6F2 Ramp Type: Perp			Initial	Initial Pass/Fail: Fail Overall Compliance: No				o Severity Score:	21.25
Codes/Mitigation Info/Possible Solution				Field Measurements/Component Compliance						
	Sec. 1	Possible Solutions:			Compliance Description			Data Compliance Description		Data
	1/2 5	Remove & Replace Enti	re Ram	p.	N/A	Ramp Length (in)	72.0	No	Ramp Slope (%)	9.0
	10 2				No	Ramp Width (in)	47.0	Yes	Ramp XSlope (%)	1.5
	1 1				N/A	Flare Type LT	N/A	N/A	Flare Type RT	N/A

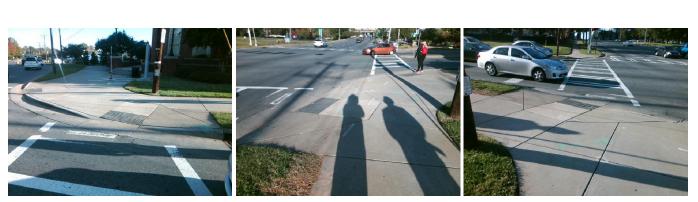
E.				N/A	Flare Slope LT (%)	N/A	N/A	Flare Slope RT (%)	N/A
	-				N/A	Flare Traversable LT?	N/A	N/A	Flare Traversable RT?	N/A
A B					N/A	Landing Length (in)	N/A	N/A	DWS Provided?	N/A
A Mile A	1 6	Surveyor Notes:			N/A	Landing Width (in)	N/A	N/A	DWS Contrast?	N/A
A BA	I good	N/A			N/A	Landing Slope (%)	N/A	N/A	DWS Length (in)	N/A
E STROP	10	2			N/A	Landing X Slope (%)	N/A	N/A	DWS Full Width?	N/A
and the second	2 8/2	-			N/A	Landing Curb? (Y/N)	N/A	N/A	DWS Offset (in)	N/A
a star	Sam 11	ŧ			N/A	Shared Landing?	N/A			
		PROW/ADA:			N/A	Gutter Ponding?	N/A	N/A	Gutter Slope (%)	N/A
E CON	STOP -	Not Found, R304.5.1, R	304.2.2		N/A	Gutter Lip Ht (in)	N/A	N/A	Gutter X Slope (%)	N/A
	40p				N/A	Painted X Walk1?	Yes	N/A	Painted X Walk2?	N/A
	1					X Walk 1 Direction	To SW		X Walk 2 Direction	N/A
				N/A	X Walk 1 Width (in)	106.0	N/A	X Walk 2 Width (in)	N/A	
Street 1 Name	E 4TH ST					X Walk 1 Slope (%)	3.0		X Walk 2 Slope (%)	N/A

Stop Condition-Street 2	Signal					X Walk 1 X Slope (%)	2.0		X Walk 2 X Slope (%)	N/A
Street 2 Name	N/A				N/A	Ramp inside XWalk1?	Yes	N/A	Ramp inside XWalk2?	N/A
Stop Condition-Street 1	N/A					Road Slope (%)	N/A	N/A	Clear Space?	N/A
						Road X Slope (%)	N/A	N/A	Clear Space to XWalk (in)	N/A
					N/A	Any Obstructions?	N/A	N/A	Storm Grate/Utility Hazard?	N/A
		Total Cost:	\$	1850.00		Obstruction Type			Storm Grate/Utility Type	
							N/A			N/A
