Access Compliance Report

Public Rights-of-Way

(Curb Ramps)

Intersection ID: 50604	Main Street: RHODORA_RD	Cross Street: LAMINA_CT	Location: SW
ADA ID: 38299F4F659F	Ramp Type: Perp	Initial Pass/Fail: Fail	Overall Compliance: No
Severity Score: 10			
Codes/Mitigation Info/Possible Solution		Field Measurements/Component Compliance

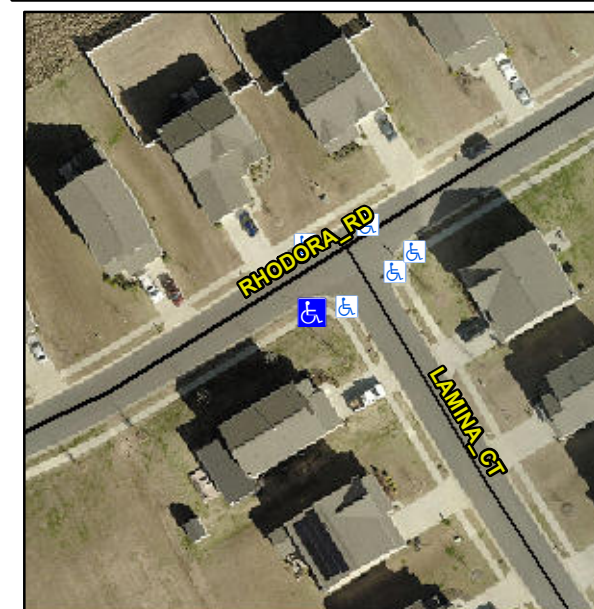
Not Found, R304.5.1

Compliance	Description	Data	Compliance	Description	Data
N/A	Ramp Length (in)	49.0	Yes	Ramp Slope (%)	6.5
No	Ramp Width (in)	46.5	Yes	Ramp XSlope (%)	2.6
N/A	Flare Type LT	N/A	N/A	Flare Type RT	N/A
N/A	Flare Slope LT (%)	N/A	N/A	Flare Slope RT (%)	N/A
N/A	Flare Traversable LT?	N/A	N/A	Flare Traversable RT?	N/A
N/A	Landing Length (in)	N/A	N/A	DWS Provided?	N/A
N/A	Landing Width (in)	N/A	N/A	DWS Contrast?	N/A
N/A	Landing Slope (%)	N/A	N/A	DWS Length (in)	N/A
N/A	Landing X Slope (%)	N/A	N/A	DWS Full Width?	N/A
N/A	Landing Curb? (Y/N)	N/A	N/A	DWS Offset (in)	N/A
N/A	Shared Landing?	N/A			
N/A	Gutter Ponding?	N/A	N/A	Gutter Slope (%)	N/A
N/A	Gutter Lip Ht (in)	N/A	N/A	Gutter X Slope (%)	N/A
N/A	Painted X Walk1?	No	N/A	Painted X Walk2?	N/A
	X Walk 1 Direction	To N		X Walk 2 Direction	N/A
N/A	X Walk 1 Width (in)	N/A	N/A	X Walk 2 Width (in)	N/A
	X Walk 1 Slope (%)	2.9		X Walk 2 Slope (%)	N/A
	X Walk 1 X Slope (%)	3.2		X Walk 2 X Slope (%)	N/A

Remove & Replace Entire Ramp.

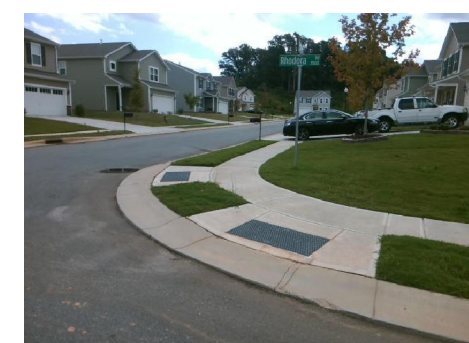
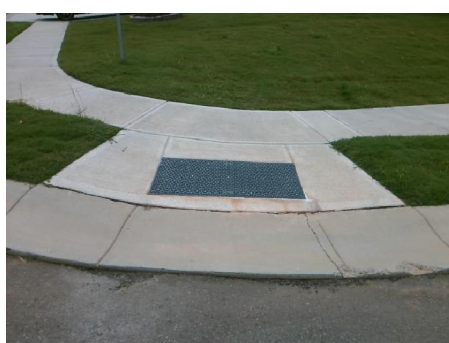
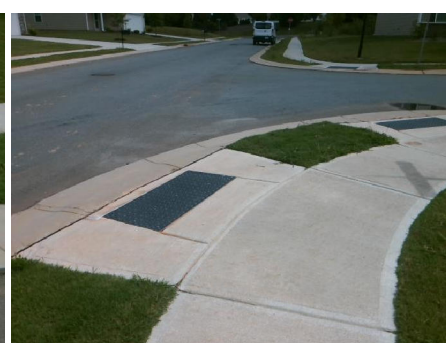
N/A	Ramp inside XWalk1?	N/A	N/A	Ramp inside XWalk2?	N/A
	Road Slope (%)	N/A	N/A	Clear Space?	N/A
	Road X Slope (%)	N/A	N/A	Clear Space to XWalk (in)	N/A
N/A	Any Obstructions?	N/A	N/A	Storm Grate/Utility Hazard?	N/A
	Obstruction Type			Storm Grate/Utility Type	
		N/A			N/A
			Yes	Surface Condition? (G/P)	Good
