# Access Compliance Report

## Public Rights-of-Way

Intersection ID: 2850	Main Street: BEAUVISTA_DR	Cross Street: PECAN_COVE_LN	Location: NE
ADA ID: 382F4127C41B	Ramp Type: PerpDiag	Initial Pass/Fail: Fail	Overall Compliance: No
Severity Score: 46.25			
Codes/Mitigation Info/Possible Solution		Field Measurements/Component Compliance

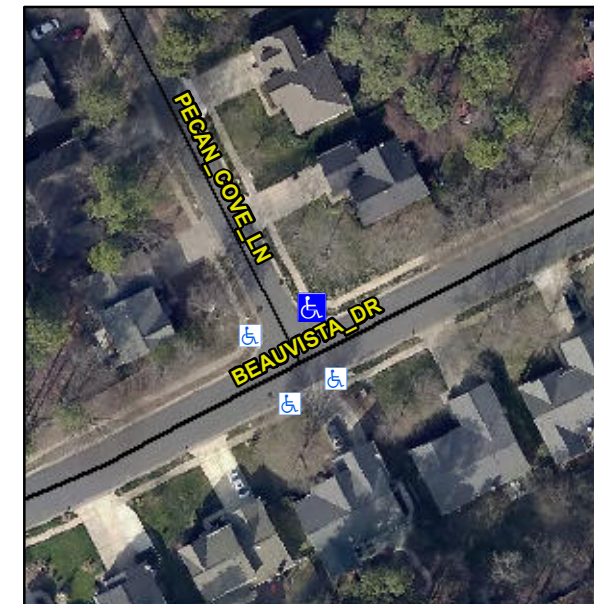
**Not Found, R304.5.1, R304.2.2, R304.5.3**

Compliance	Description	Data	Compliance	Description	Data
N/A	Ramp Length (in)	45.0	No	Ramp Slope (%)	8.9
No	Ramp Width (in)	40.0	No	Ramp XSlope (%)	8.0
N/A	Flare Type LT	N/A	N/A	Flare Type RT	N/A
N/A	Flare Slope LT (%)	N/A	N/A	Flare Slope RT (%)	N/A
N/A	Flare Traversable LT?	N/A	N/A	Flare Traversable RT?	N/A
N/A	Landing Length (in)	N/A	N/A	DWS Provided?	N/A
N/A	Landing Width (in)	N/A	N/A	DWS Contrast?	N/A
N/A	Landing Slope (%)	N/A	N/A	DWS Length (in)	N/A
N/A	Landing X Slope (%)	N/A	N/A	DWS Full Width?	N/A
N/A	Landing Curb? (Y/N)	N/A	N/A	DWS Offset (in)	N/A
N/A	Shared Landing?	N/A			
N/A	Gutter Ponding?	N/A	N/A	Gutter Slope (%)	N/A
N/A	Gutter Lip Ht (in)	N/A	N/A	Gutter X Slope (%)	N/A
N/A	Painted X Walk1?	No	N/A	Painted X Walk2?	No
	X Walk 1 Direction	To W		X Walk 2 Direction	To S
N/A	X Walk 1 Width (in)	N/A	N/A	X Walk 2 Width (in)	N/A
	X Walk 1 Slope (%)	1.1		X Walk 2 Slope (%)	7.2
	X Walk 1 X Slope (%)	4.3		X Walk 2 X Slope (%)	2.3

N/A	Ramp inside XWalk1?	N/A	N/A	Ramp inside XWalk2?	N/A
	Road Slope (%)	4.4	N/A	Clear Space?	N/A
	Road X Slope (%)	3.2	N/A	Clear Space to XWalk (in)	N/A
N/A	Any Obstructions?	N/A	N/A	Storm Grate/Utility Hazard?	N/A
	Obstruction Type			Storm Grate/Utility Type	
		N/A			N/A
			Yes	Surface Condition? (G/P)	Good

**Remove & Replace Curb Ramp With Two New Directional Ramps or Equivalent.**
