## Access Compliance Report Public Rights-of-Way (Curb Ramps)

Intersection ID: 48427 Main Street: DURNESS\_DR Cross Street: EVANTON\_LOCH\_RD Location: SE

ADA ID: 383153217049 Ramp Type: PerpDiag Initial Pass/Fail: Fail Overall Compliance: No Severity Score: 21.25

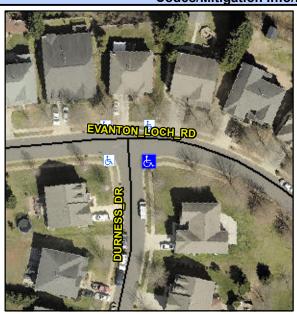
R304.5.1, R304.5.3

| Field Measurements/Component Compliance | | | | | |
|---|---|---|---|---|---|
| N/A | Ramp Length (in) | 48.0 | Yes | Ramp Slope (%) | 5.2 |
| No | Ramp Width (in) | 41.0 | No | Ramp XSlope (%) | 5.7 |

Remove & Replace Curb Ramp With Two New Directional Ramps or Equivalent.

Total Cost: \$ 3200.00
