| Intersection ID: 48432 | Main Street: WHITHORN_WY | Cross Street: SEAMILL_RD | Location: | NE |
| ADA ID: 384BD127E4CA | Ramp Type: PerpDiag | Initial Pass/Fail: Fail | Overall Compliance: No | Severity Score: 13.75 |

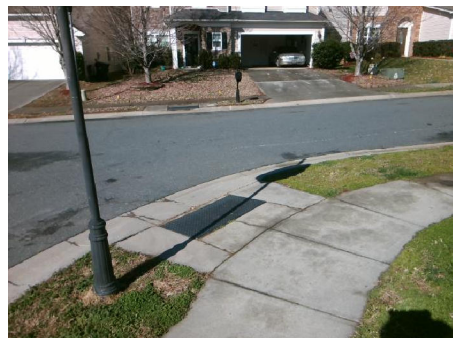
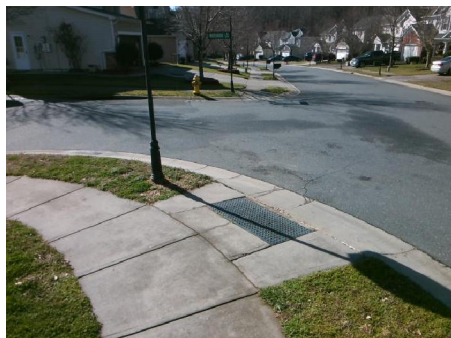
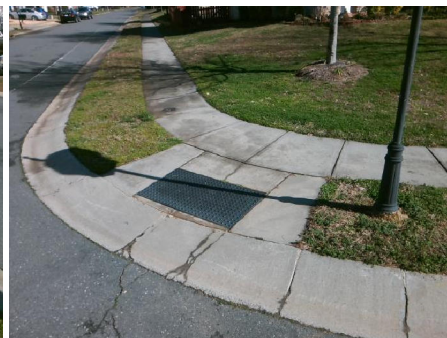
**Not Found, R304.2.2, R304.5.3**

| Compliance | Description | Data | Compliance | Description | Data |
|---|---|---|---|---|---|
| N/A | Ramp Length (in) | 47.0 | No | Ramp Slope (%) | 10.0 |
| Yes | Ramp Width (in) | 48.0 | No | Ramp XSlope (%) | 2.1 |

**Remove & Replace Curb Ramp With Two New Directional Ramps or Equivalent.**

Total Cost: \$ 3200.00
