Access Compliance Report

Public Rights-of-Way

(Curb Ramps)

Intersection ID: 54318	Main Street: CANTERBURY_CASTLE_DR	Cross Street: BELMONT_MANSION_DR	Location: NE
ADA ID: 385716EDD4ED	Ramp Type: Perp	Initial Pass/Fail: Fail	Overall Compliance: No
		Severity Score: 12.5

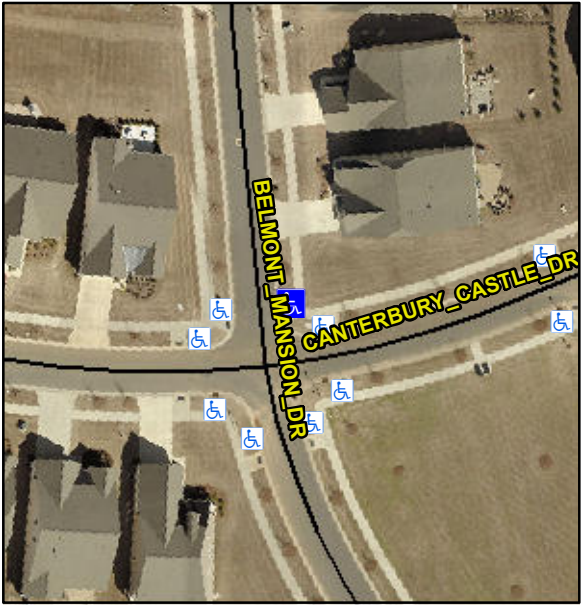
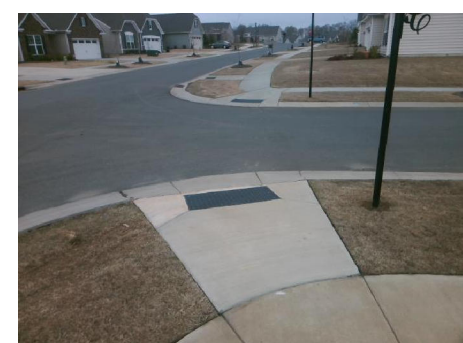
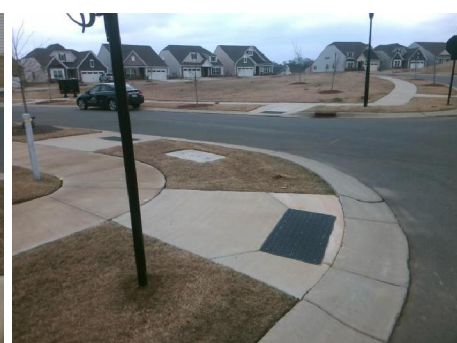
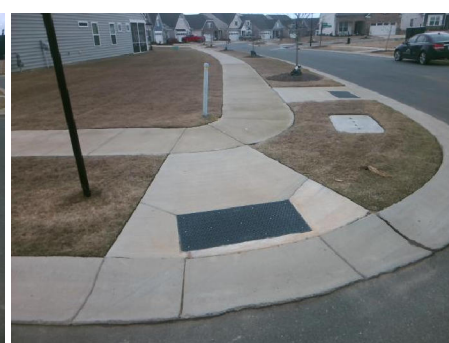
Possible Solutions:		Compliance	Description	Data
	Remove & Replace Entire Ramp.		N/A	Ramp Length (in)	99.0
			Yes	Ramp Width (in)	48.0
			N/A	Flare Type LT	N/A
			N/A	Flare Slope LT (%)	N/A
			N/A	Flare Traversable LT?	N/A
			N/A	Landing Length (in)	N/A
			N/A	Landing Width (in)	N/A
			N/A	Landing Slope (%)	N/A
			N/A	Landing X Slope (%)	N/A
<p>Surveyor Notes:</p> <p>N/A</p> <p>PROW/ADA:</p> <p>R304.2.2</p>			N/A	Flare Type RT	N/A
			N/A	Flare Slope RT (%)	N/A
			N/A	Flare Traversable RT?	N/A
			N/A	DWS Provided?	N/A
			N/A	DWS Contrast?	N/A
			N/A	DWS Length (in)	N/A
			N/A	DWS Full Width?	N/A
			N/A	DWS Offset (in)	N/A
			N/A	Shared Landing?	N/A
			N/A	Gutter Ponding?	N/A
			N/A	Gutter Lip Ht (in)	1.0
			N/A	Painted X Walk1?	No
				X Walk 1 Direction	To W
			N/A	X Walk 1 Width (in)	N/A
				X Walk 1 Slope (%)	2.8
				X Walk 1 X Slope (%)	2.4

N/A	Ramp inside XWalk1?	N/A
				Road Slope (%)	N/A
				Road X Slope (%)	N/A
			N/A	Any Obstructions?	N/A
				Obstruction Type	
Total Cost:		\$ 1850.00			
			N/A		N/A
			Yes	Surface Condition? (G/P)	Good
