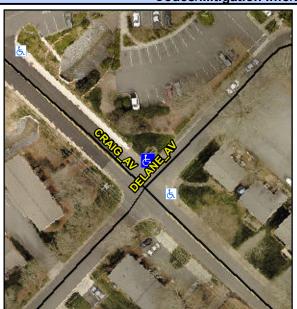
Intersection ID: 16947Main Street: CRAIG_AVCross Street: DELANE_AVLocation:NADA ID: 38593062E0F3Ramp Type: PerpDiagInitial Pass/Fail: FailOverall Compliance: NoSeverity Score:25

Not Found, R304.2.2, R304.5.3

Compliance Description		Data	Compliance Description		Data
N/A	Ramp Length (in)	49.0	No	Ramp Slope (%)	9.6
Yes	Ramp Width (in)	48.0	No	Ramp XSlope (%)	5.6
N/A	Flare Type LT	N/A	N/A	Flare Type RT	N/A
N/A	Flare Slope LT (%)	N/A	N/A	Flare Slope RT (%)	N/A
N/A	Flare Traversable LT?	N/A	N/A	Flare Traversable RT?	N/A
N/A	Landing Length (in)	N/A	N/A	DWS Provided?	N/A
N/A	Landing Width (in)	N/A	N/A	DWS Contrast?	N/A
N/A	Landing Slope (%)	N/A	N/A	DWS Length (in)	N/A
N/A	Landing X Slope (%)	N/A	N/A	DWS Full Width?	N/A
N/A	Landing Curb? (Y/N)	N/A	N/A	DWS Offset (in)	N/A
N/A	Shared Landing?	N/A			
N/A	Gutter Ponding?	N/A	N/A	Gutter Slope (%)	N/A
N/A	Gutter Lip Ht (in)	N/A	N/A	Gutter X Slope (%)	N/A
N/A	Painted X Walk1?	No	N/A	Painted X Walk2?	No
	X Walk 1 Direction	To SE		X Walk 2 Direction	To SW
N/A	X Walk 1 Width (in)	N/A	N/A	X Walk 2 Width (in)	N/A
	X Walk 1 Slope (%)	0.3		X Walk 2 Slope (%)	7.2
	X Walk 1 X Slope (%)	6.9		X Walk 2 X Slope (%)	1.0

N/A	Ramp inside XWalk1?	N/A	N/A	Ramp inside XWalk2?	N/A
	Road Slope (%)	5.7	N/A	Clear Space?	N/A
	Road X Slope (%)	5.2	N/A	Clear Space to XWalk (in)	N/A
N/A	Any Obstructions?	N/A	N/A	Storm Grate/Utility Hazard?	N/A
	Obstruction Type		l	Storm Grate/Utility Type	
		N/A			N/A

Remove & Replace Curb Ramp With Two New Directional Ramps or Equivalent.
