# Access Compliance Report

## Public Rights-of-Way

### (Curb Ramps)

| Intersection ID: 14757 | Main Street: E_WORTHINGTON_AV | Cross Street: LENNOX_AV | Location: S |

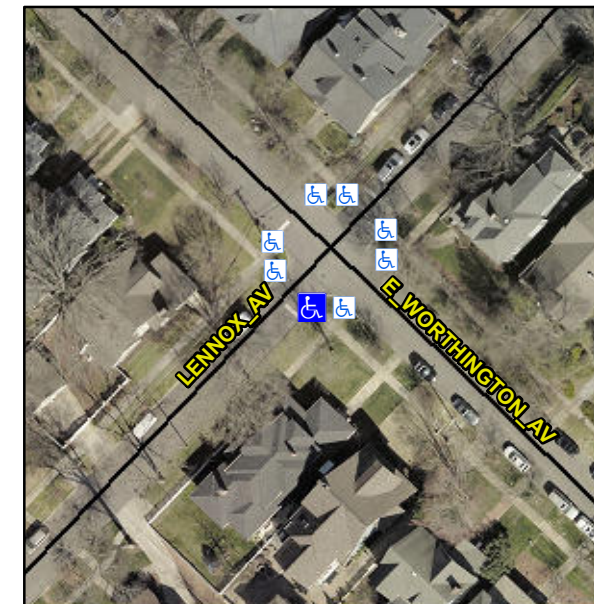
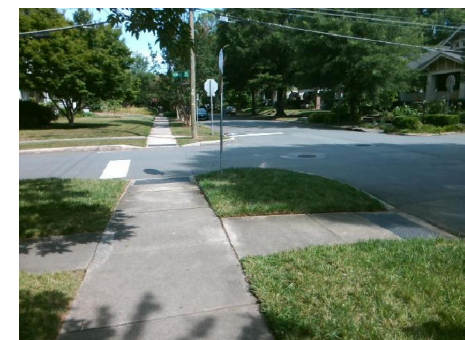
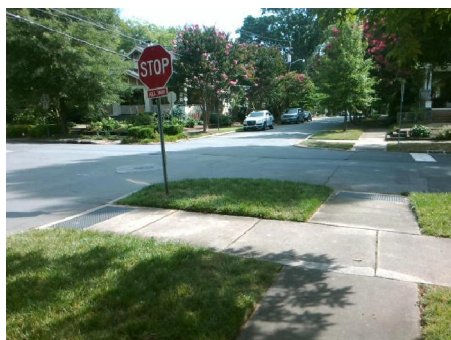
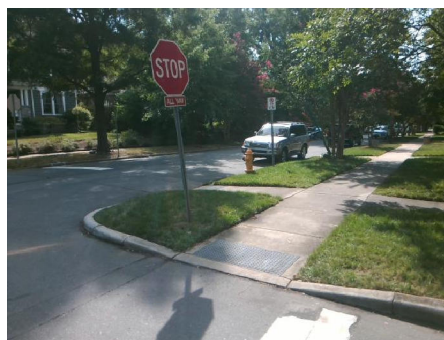
**Not Found, R305.1.4, R302.7.2**

| Compliance | Description | Data | Compliance | Description | Data |
|---|---|---|---|---|---|
| N/A | Landing X Slope (%) | N/A | No | DWS Full Width? | No |
| No | Gutter Lip Ht (in) | 1.0 | Yes | Gutter X Slope (%) | 1.8 |
| | | | No | Curb Slope (%) | 17.1 |

**Remove & Replace Curb Ramp With Two New Directional Ramps or Equivalent.**
