## **Access Compliance Report Public Rights-of-Way** (Curb Ramps)

**Cross Street: GARLAND CT** Intersection ID: 45177 Main Street: ELDON DR Location: NW Initial Pass/Fail: Fail **Overall Compliance: No** 35 ADA ID: 386BC589B583 Ramp Type: Perp **Severity Score:**

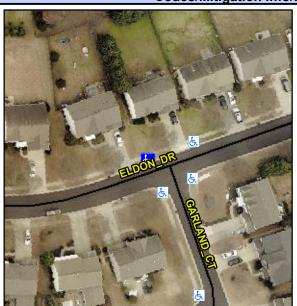
Possible Solutions:	Compliance Description
Remove & Replace Entire Ramp.	N/A Ramp Length (in)
·	<b>No</b> Ramp Width (in)
	N/A Flare Type LT
	N/A Flare Slope LT (%)
	N/A Flare Traversable L
	N/A Landing Length (in)
Surveyor Notes:	N/A Landing Width (in)
N/A	N/A Landing Slope (%)
	N/A Landing X Slope (%
	N/A Landing Curb? (Y/N
	N/A Shared Landing?
PROW/ADA:	N/A Gutter Ponding?
Not Found, R304.5.1, R304.2.2,	N/A Gutter Lip Ht (in)
R304.5.3	N/A Painted X Walk1?
	X Walk 1 Direction
	N/A X Walk 1 Width (in)
	X Walk 1 Slope (%)
	X Walk 1 X Slope (9
	N/A Ramp inside XWalk
