Access Compliance Report

Public Rights-of-Way

(Curb Ramps)

Intersection ID: 20571	Main Street: CAMERON_VALLEY_PY	Cross Street: FAIRVIEW_RD	Location: SW
ADA ID: 3878F739C72B	Ramp Type: PerpDiag	Initial Pass/Fail: Fail	Overall Compliance: No
		Severity Score: 12.5

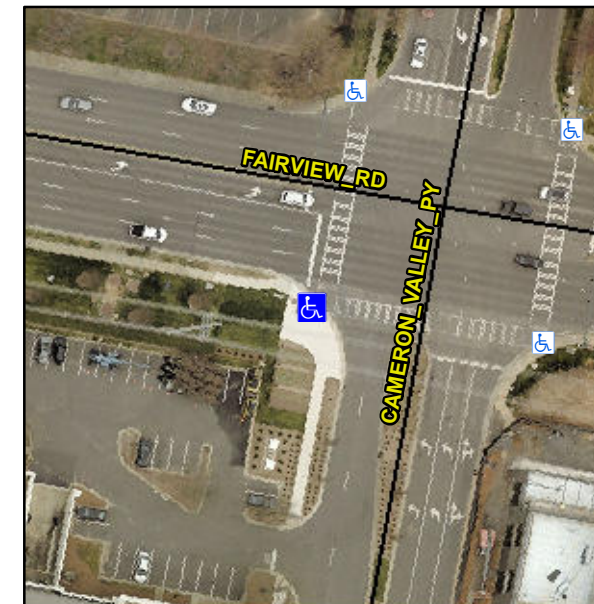
Not Found, R304.2.2

Compliance	Description	Data	Compliance	Description	Data
N/A	Ramp Length (in)	59.5	No	Ramp Slope (%)	8.7
Yes	Ramp Width (in)	51.0	Yes	Ramp XSlope (%)	2.0
N/A	Flare Type LT	N/A	N/A	Flare Type RT	N/A
N/A	Flare Slope LT (%)	N/A	N/A	Flare Slope RT (%)	N/A
N/A	Flare Traversable LT?	N/A	N/A	Flare Traversable RT?	N/A
N/A	Landing Length (in)	N/A	N/A	DWS Provided?	N/A
N/A	Landing Width (in)	N/A	N/A	DWS Contrast?	N/A
N/A	Landing Slope (%)	N/A	N/A	DWS Length (in)	N/A
N/A	Landing X Slope (%)	N/A	N/A	DWS Full Width?	N/A
N/A	Landing Curb? (Y/N)	N/A	N/A	DWS Offset (in)	N/A
N/A	Shared Landing?	N/A			
N/A	Gutter Ponding?	N/A	N/A	Gutter Slope (%)	N/A
N/A	Gutter Lip Ht (in)	N/A	N/A	Gutter X Slope (%)	N/A
N/A	Painted X Walk1?	Yes	N/A	Painted X Walk2?	Yes
	X Walk 1 Direction	To SE		X Walk 2 Direction	To NE
N/A	X Walk 1 Width (in)	103.0	N/A	X Walk 2 Width (in)	105.0
	X Walk 1 Slope (%)	2.1		X Walk 2 Slope (%)	0.5
	X Walk 1 X Slope (%)	0.0		X Walk 2 X Slope (%)	3.4

N/A	Ramp inside XWalk1?	Yes	N/A	Ramp inside XWalk2?	Yes
	Road Slope (%)	1.3	N/A	Clear Space?	N/A
	Road X Slope (%)	2.0	N/A	Clear Space to XWalk (in)	N/A
N/A	Any Obstructions?	N/A	N/A	Storm Grate/Utility Hazard?	N/A
	Obstruction Type			Storm Grate/Utility Type	
		N/A			N/A
		Yes		Surface Condition? (G/P)	Good

Remove & Replace Curb Ramp With Two New Directional Ramps or Equivalent.
