Access Compliance Report

Public Rights-of-Way

(Curb Ramps)

Intersection ID: 11961	Main Street: E_18TH_ST	Cross Street: PEGRAM_ST	Location: W
ADA ID: 3880F47A22BD	Ramp Type: PerpDiag	Initial Pass/Fail: Fail	Overall Compliance: No
Severity Score: 8.75			
Codes/Mitigation Info/Possible Solution		Field Measurements/Component Compliance

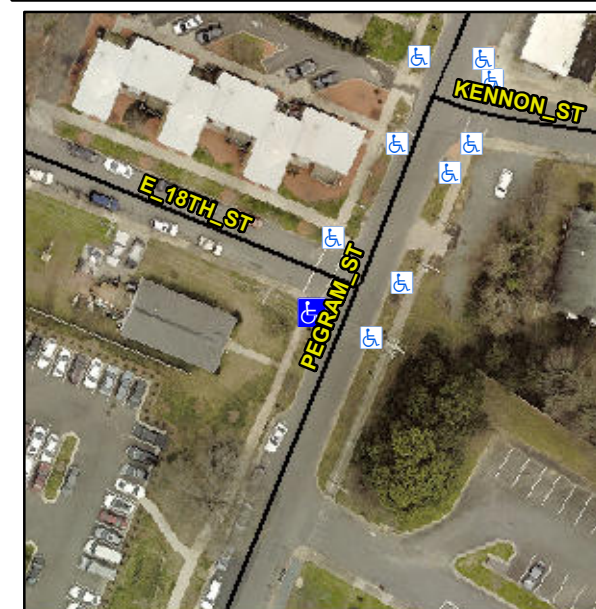
Compliance	Description	Data	Compliance	Description	Data
N/A	Ramp Length (in)	64.0	Yes	Ramp Slope (%)	8.3
No	Ramp Width (in)	47.0	Yes	Ramp XSlope (%)	0.6
N/A	Flare Type LT	N/A	N/A	Flare Type RT	N/A
N/A	Flare Slope LT (%)	N/A	N/A	Flare Slope RT (%)	N/A
N/A	Flare Traversable LT?	N/A	N/A	Flare Traversable RT?	N/A
N/A	Landing Length (in)	N/A	N/A	DWS Provided?	N/A
N/A	Landing Width (in)	N/A	N/A	DWS Contrast?	N/A
N/A	Landing Slope (%)	N/A	N/A	DWS Length (in)	N/A
N/A	Landing X Slope (%)	N/A	N/A	DWS Full Width?	N/A
N/A	Landing Curb? (Y/N)	N/A	N/A	DWS Offset (in)	N/A
N/A	Shared Landing?	N/A			
N/A	Gutter Ponding?	Yes	N/A	Gutter Slope (%)	N/A
N/A	Gutter Lip Ht (in)	N/A	N/A	Gutter X Slope (%)	N/A
N/A	Painted X Walk1?	No	N/A	Painted X Walk2?	Yes
	X Walk 1 Direction	To SE		X Walk 2 Direction	To NE
N/A	X Walk 1 Width (in)	N/A	N/A	X Walk 2 Width (in)	113.0
	X Walk 1 Slope (%)	0.5		X Walk 2 Slope (%)	2.5
	X Walk 1 X Slope (%)	1.9		X Walk 2 X Slope (%)	0.8

N/A	Ramp inside XWalk1?	N/A	N/A	Ramp inside XWalk2?	Yes
	Road Slope (%)	1.6	N/A	Clear Space?	N/A
	Road X Slope (%)	1.7	N/A	Clear Space to XWalk (in)	N/A
N/A	Any Obstructions?	N/A	N/A	Storm Grate/Utility Hazard?	N/A
	Obstruction Type			Storm Grate/Utility Type	
		N/A			N/A
		Yes		Surface Condition? (G/P)	Good

Possible Solutions:

Remove & Replace Curb Ramp With Two New Directional Ramps or Equivalent.

Not Found, R304.5.1

Total Cost: \$ 3200.00
