Access Compliance Report

Public Rights-of-Way

(Curb Ramps)

Intersection ID: 10020377	Main Street: BALLANTYNE_CORPORATE_PC	Cross Street: N/A	Location: SE
ADA ID: 38A685111931	Ramp Type: Perp	Initial Pass/Fail: Fail	Overall Compliance: No
Severity Score: 58.75			
Codes/Mitigation Info/Possible Solution		Field Measurements/Component Compliance

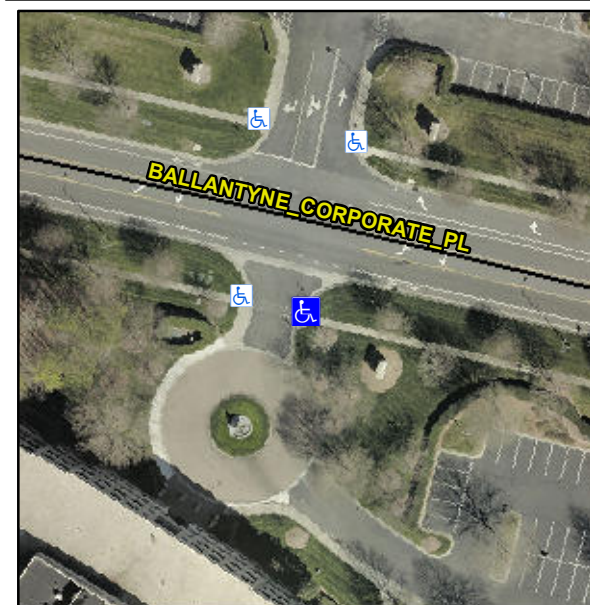
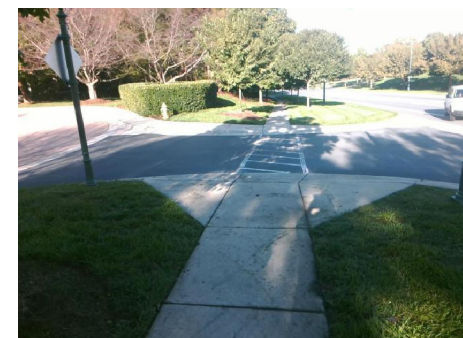
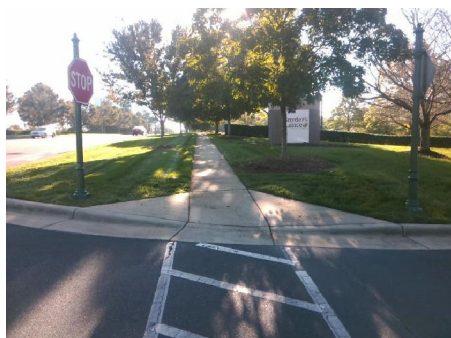
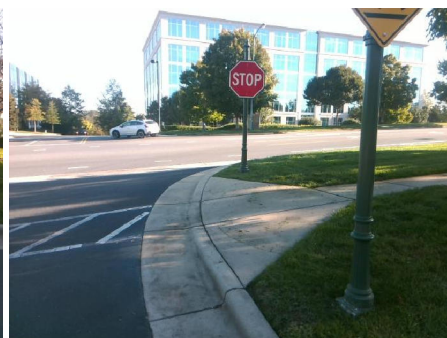
R304.5.1, R304.2.2, R304.5.3

Compliance	Description	Data	Compliance	Description	Data
N/A	Ramp Length (in)	84.0	No	Ramp Slope (%)	13.1
No	Ramp Width (in)	47.0	No	Ramp XSlope (%)	7.6
N/A	Flare Type LT	N/A	N/A	Flare Type RT	N/A
N/A	Flare Slope LT (%)	N/A	N/A	Flare Slope RT (%)	N/A
N/A	Flare Traversable LT?	N/A	N/A	Flare Traversable RT?	N/A
N/A	Landing Length (in)	N/A	N/A	DWS Provided?	N/A
N/A	Landing Width (in)	N/A	N/A	DWS Contrast?	N/A
N/A	Landing Slope (%)	N/A	N/A	DWS Length (in)	N/A
N/A	Landing X Slope (%)	N/A	N/A	DWS Full Width?	N/A
N/A	Landing Curb? (Y/N)	N/A	N/A	DWS Offset (in)	N/A
N/A	Shared Landing?	N/A			
N/A	Gutter Ponding?	N/A	N/A	Gutter Slope (%)	N/A
N/A	Gutter Lip Ht (in)	N/A	N/A	Gutter X Slope (%)	N/A
N/A	Painted X Walk1?	Yes	N/A	Painted X Walk2?	N/A
	X Walk 1 Direction	To NW		X Walk 2 Direction	N/A
N/A	X Walk 1 Width (in)	50.0	N/A	X Walk 2 Width (in)	N/A
	X Walk 1 Slope (%)	7.9		X Walk 2 Slope (%)	N/A
	X Walk 1 X Slope (%)	3.4		X Walk 2 X Slope (%)	N/A

N/A	Ramp inside XWalk1?	Yes	N/A	Ramp inside XWalk2?	N/A
	Road Slope (%)	N/A	N/A	Clear Space?	N/A
	Road X Slope (%)	N/A	N/A	Clear Space to XWalk (in)	N/A
N/A	Any Obstructions?	N/A	N/A	Storm Grate/Utility Hazard?	N/A
	Obstruction Type			Storm Grate/Utility Type	
		N/A			N/A
		Yes		Surface Condition? (G/P)	Good

Remove & Replace Entire Ramp.

Total Cost: \$ **1850.00**
