Access Compliance Report

Public Rights-of-Way

(Curb Ramps)

Intersection ID: 12517	Main Street: N_SHARON_AMITY_RD	Cross Street: SHAMROCK_DR	Location: NE
ADA ID: 38B34A1CC14F	Ramp Type: Perp	Initial Pass/Fail: Fail	Overall Compliance: No
Codes/Mitigation Info/Possible Solution		Field Measurements/Component Compliance

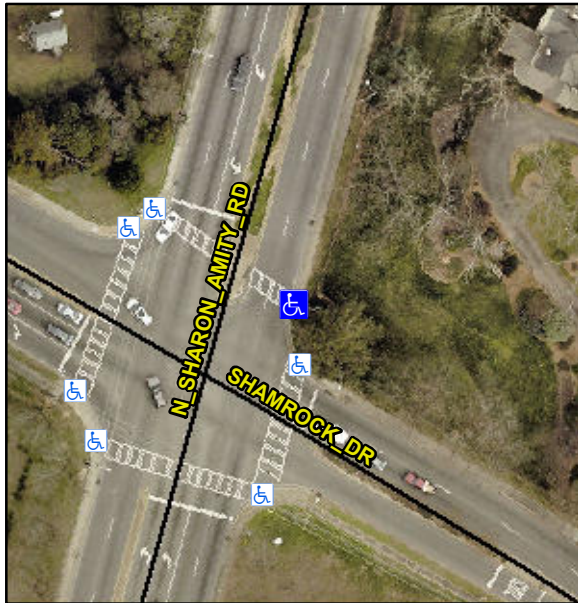
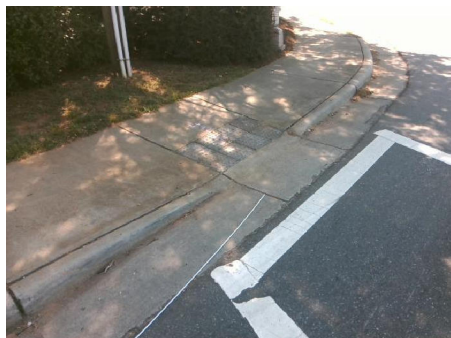
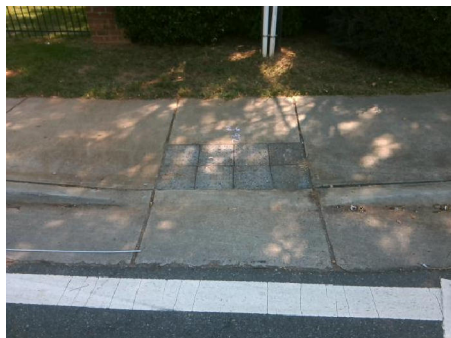
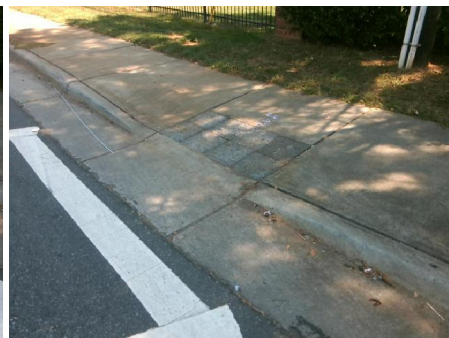
Not Found, R304.2.2, R304.5.3

Compliance	Description	Data	Compliance	Description	Data
N/A	Ramp Length (in)	59.5	No	Ramp Slope (%)	9.2
Yes	Ramp Width (in)	48.0	No	Ramp XSlope (%)	2.6
N/A	Flare Type LT	N/A	N/A	Flare Type RT	N/A
N/A	Flare Slope LT (%)	N/A	N/A	Flare Slope RT (%)	N/A
N/A	Flare Traversable LT?	N/A	N/A	Flare Traversable RT?	N/A
N/A	Landing Length (in)	N/A	N/A	DWS Provided?	N/A
N/A	Landing Width (in)	N/A	N/A	DWS Contrast?	N/A
N/A	Landing Slope (%)	N/A	N/A	DWS Length (in)	N/A
N/A	Landing X Slope (%)	N/A	N/A	DWS Full Width?	N/A
N/A	Landing Curb? (Y/N)	N/A	N/A	DWS Offset (in)	N/A
N/A	Shared Landing?	N/A			
N/A	Gutter Ponding?	N/A	N/A	Gutter Slope (%)	N/A
N/A	Gutter Lip Ht (in)	N/A	N/A	Gutter X Slope (%)	N/A
N/A	Painted X Walk1?	Yes	N/A	Painted X Walk2?	N/A
	X Walk 1 Direction	To NW		X Walk 2 Direction	N/A
N/A	X Walk 1 Width (in)	96.5	N/A	X Walk 2 Width (in)	N/A
	X Walk 1 Slope (%)	1.2		X Walk 2 Slope (%)	N/A
	X Walk 1 X Slope (%)	0.3		X Walk 2 X Slope (%)	N/A

N/A	Ramp inside XWalk1?	Yes	N/A	Ramp inside XWalk2?	N/A
	Road Slope (%)	N/A	N/A	Clear Space?	N/A
	Road X Slope (%)	N/A	N/A	Clear Space to XWalk (in)	N/A
N/A	Any Obstructions?	N/A	N/A	Storm Grate/Utility Hazard?	N/A
	Obstruction Type			Storm Grate/Utility Type	
		N/A			N/A
			Yes	Surface Condition? (G/P)	Good

Remove & Replace Entire Ramp.
