Access Compliance Report

Public Rights-of-Way

(Curb Ramps)

Intersection ID: 7448	Main Street: ROCKY_RIVER_RD	Cross Street: GRIER_RD	Location: S
ADA ID: 38B67E539413	Ramp Type: Perp	Initial Pass/Fail: Fail	Overall Compliance: No
		Severity Score: 12.5

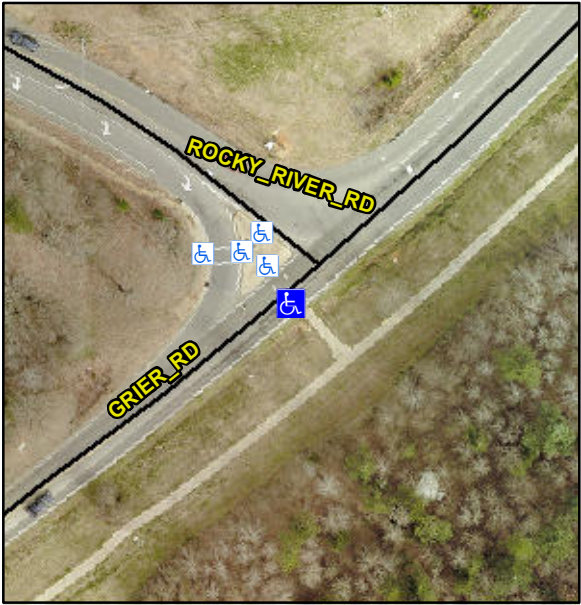
Possible Solutions:		Compliance	Description	Data
	Remove & Replace Entire Ramp.		N/A	Ramp Length (in)	38.0
			Yes	Ramp Width (in)	59.0
			N/A	Flare Type LT	N/A
			N/A	Flare Slope LT (%)	N/A
			N/A	Flare Traversable LT?	N/A
			N/A	Landing Length (in)	N/A
			N/A	Landing Width (in)	N/A
			N/A	Landing Slope (%)	N/A
			N/A	Landing X Slope (%)	N/A
<p>Surveyor Notes:</p> <p>N/A</p> <p>PROW/ADA:</p> <p>R304.2.2</p>			N/A	Flare Type RT	N/A
			N/A	Flare Slope RT (%)	N/A
			N/A	Flare Traversable RT?	N/A
			N/A	DWS Provided?	N/A
			N/A	DWS Contrast?	N/A
			N/A	DWS Length (in)	N/A
			N/A	DWS Full Width?	N/A
			N/A	DWS Offset (in)	N/A
			N/A	Shared Landing?	N/A
			N/A	Gutter Ponding?	N/A
			N/A	Gutter Lip Ht (in)	N/A
			N/A	Painted X Walk1?	Yes
				X Walk 1 Direction	To NW
			N/A	X Walk 1 Width (in)	87.0
				X Walk 1 Slope (%)	1.2
				X Walk 1 X Slope (%)	1.4

N/A	Ramp inside XWalk1?	Yes
			N/A	Road Slope (%)	N/A
			N/A	Road X Slope (%)	N/A
			N/A	Any Obstructions?	N/A
				Obstruction Type	
Total Cost:		\$ 1850.00			
			N/A		N/A
			Yes	Surface Condition? (G/P)	Good
