## **Access Compliance Report Public Rights-of-Way** (Curb Ramps)

Intersection ID: 16453 Main Street: MARVIN\_RD **Cross Street: N WENDOVER RD** Location: NW ADA ID: 38C7CBAF51AD Ramp Type: PerpDiag Initial Pass/Fail: Fail **Overall Compliance: No** Severity Score: 21.25

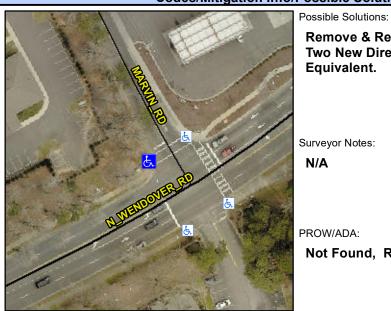
Not Found, R304.5.1, R304.2.2

Comp	liance Description	Data	Comp	liance Description	Data
N/A	Ramp Length (in)	77.0	No	Ramp Slope (%)	10.0
No	Ramp Width (in)	36.0	Yes	Ramp XSlope (%)	0.6
N/A	Flare Type LT	N/A	N/A	Flare Type RT	N/A
N/A	Flare Slope LT (%)	N/A	N/A	Flare Slope RT (%)	N/A
N/A	Flare Traversable LT?	N/A	N/A	Flare Traversable RT?	N/A
N/A	Landing Length (in)	N/A	N/A	DWS Provided?	N/A
N/A	Landing Width (in)	N/A	N/A	DWS Contrast?	N/A
N/A	Landing Slope (%)	N/A	N/A	DWS Length (in)	N/A
N/A	Landing X Slope (%)	N/A	N/A	DWS Full Width?	N/A
N/A	Landing Curb? (Y/N)	N/A	N/A	DWS Offset (in)	N/A
N/A	Shared Landing?	N/A			
N/A	Gutter Ponding?	N/A	N/A	Gutter Slope (%)	N/A
N/A	Gutter Lip Ht (in)	N/A	N/A	Gutter X Slope (%)	N/A
N/A	Painted X Walk1?	No	N/A	Painted X Walk2?	Yes
	X Walk 1 Direction	To S		X Walk 2 Direction	To E
N/A	X Walk 1 Width (in)	N/A	N/A	X Walk 2 Width (in)	105.0
	X Walk 1 Slope (%)	0.8		X Walk 2 Slope (%)	1.5
	X Walk 1 X Slope (%)	3.4		X Walk 2 X Slope (%)	3.0

N/A	Ramp inside XWalk1?	N/A	N/A	Ramp inside XWalk2?	Yes
	Road Slope (%)	2.3	N/A	Clear Space?	N/A
	Road X Slope (%)	3.2	N/A	Clear Space to XWalk (in)	N/A
N/A	Any Obstructions?	N/A	N/A	Storm Grate/Utility Hazard?	N/A
	Obstruction Type			Storm Grate/Utility Type	
		N/A			N/A
			Yes	Surface Condition? (G/P)	Good

Remove & Replace Curb Ramp Wit **Two New Directional Ramps or** Equivalent.

Total Cost: 3200.00
