Access Compliance Report

Public Rights-of-Way

(Curb Ramps)

Intersection ID: 10770	Main Street: ALICE_AV	Cross Street: TUCKASEEGEE_RD	Location:	E
ADA ID: 38CB48673AA7	Ramp Type: Directional1	Initial Pass/Fail: Fail	Overall Compliance: No	Severity Score: 25
Codes/Mitigation Info/Possible Solution		Field Measurements/Component Compliance

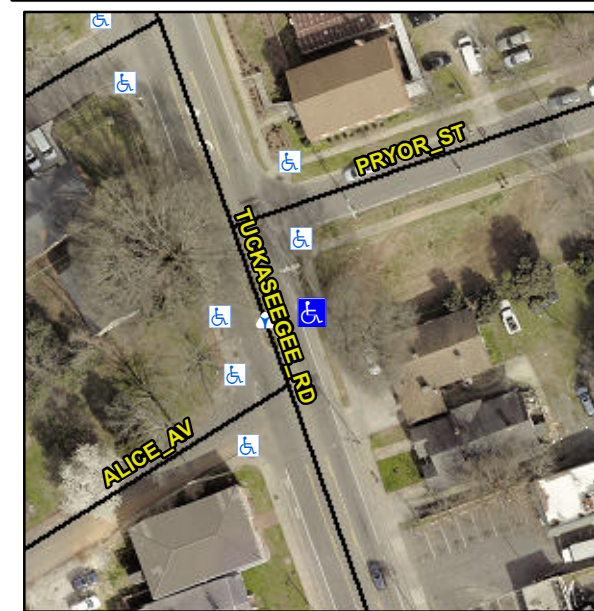
Compliance	Description	Data	Compliance	Description	Data
N/A	Ramp Length (in)	49.0	N/A	Grade Break?	N/A
Yes	Ramp Width (in)	50.5	N/A	Grade Break Slope (%)	0.0
No	Ramp Slope (%)	17.6	N/A	Grade Break XSlope (%)	0.0
Yes	Ramp XSlope (%)	1.3			
N/A	Flare Type LT	N/A	N/A	Flare Type RT	N/A
N/A	Flare Slope LT (%)	N/A	N/A	Flare Slope RT (%)	0.0
N/A	Flare Traversable LT?	N/A	N/A	Flare Traversable RT?	N/A
N/A	Landing Length (in)	0.0	N/A	DWS Provided?	N/A
N/A	Landing Width (in)	0.0	N/A	DWS Contrast?	N/A
N/A	Landing Slope (%)	0.0	N/A	DWS Length (in)	N/A
N/A	Landing X Slope (%)	0.0	N/A	DWS Full Width?	N/A
N/A	Landing Curb? (Y/N)	N/A	N/A	DWS Offset LT (in)	N/A
N/A	Shared Landing?	N/A	N/A	DWS Offset RT (in)	N/A
N/A	Gutter Ponding?	0.0	N/A	Gutter Slope (%)	N/A
N/A	Gutter Lip Ht (in)	0.0	N/A	Gutter X Slope (%)	N/A
N/A	Painted X Walk1?	No		Road Slope (%)	5.9
	X Walk 1 Direction	To W		Road X Slope (%)	0.6
	X Walk 1 Width (in)	N/A		Clear Space?	N/A

X Walk 1 Slope (%)	5.9	N/A	Clear Space to XWalk (in)	N/A
	X Walk 1 X Slope (%)	0.6	N/A	Storm Grate/Utility Hazard?	N/A
N/A	Ramp inside XWalk1?	N/A		Storm Grate/Utility Type	
N/A	Any Obstructions?	N/A			N/A
	Obstruction Type		Yes	Surface Condition? (G/P)	Good
			N/A	Curb Slope (%)	14.6

Possible Solutions:

Remove & Replace Entire Ramp.

R304.2.2
