# Access Compliance Report

## Public Rights-of-Way

### (Curb Ramps)

Intersection ID: 4139	Main Street: FOGGY_BANK_LN	Cross Street: PITAL_CT	Location: W
ADA ID: 38DA620F8BF2	Ramp Type: BlendTrans1	Initial Pass/Fail: Fail	Overall Compliance: No
Severity Score: 33.75			
Codes/Mitigation Info/Possible Solution		Field Measurements/Component Compliance

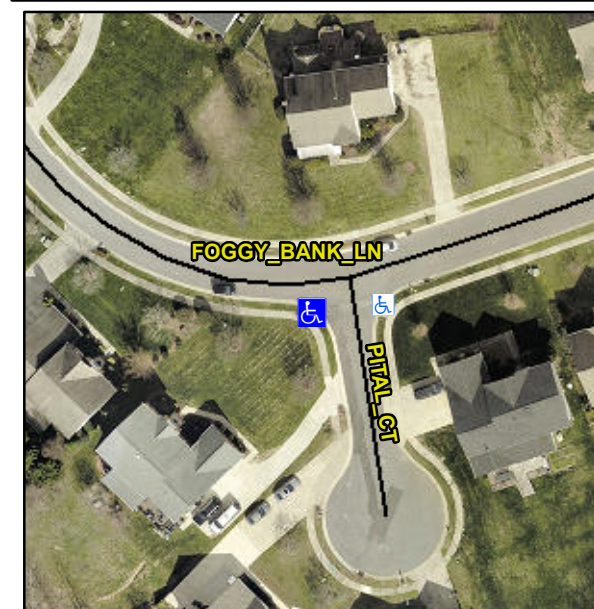
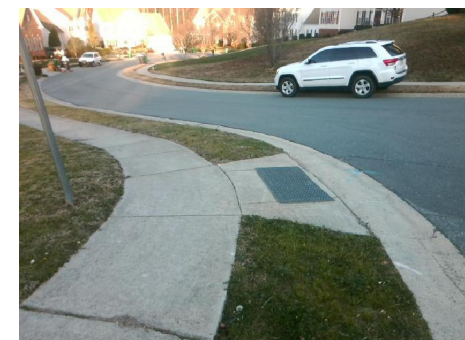
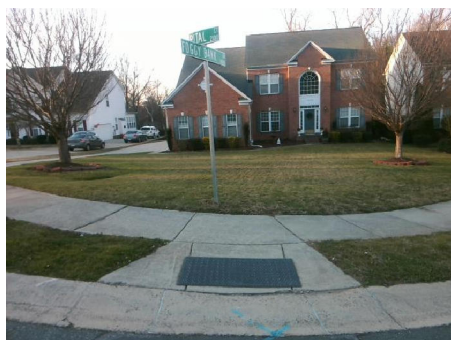
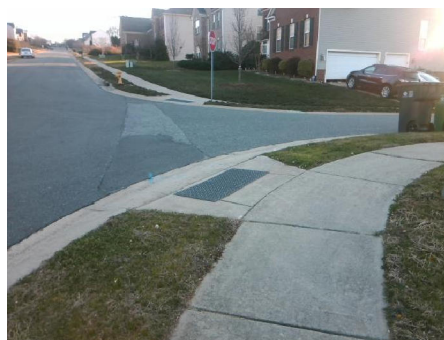
Compliance	Description	Data	Compliance	Description	Data
N/A	Ramp Length (in)	45.0	Yes	BlendTrans Slope (%)	3.1
No	Ramp Width (in)	40.5	No	BlendTrans XSlope (%)	7.2
N/A	Flare Type LT	N/A	N/A	Flare Type RT	N/A
N/A	Flare Slope LT (%)	N/A	N/A	Flare Slope RT (%)	N/A
N/A	Flare Traversable LT?	N/A	N/A	Flare Traversable RT?	N/A
N/A	Landing Length (in)	N/A	N/A	DWS Provided?	N/A
N/A	Landing Width (in)	N/A	N/A	DWS Contrast?	N/A
N/A	Landing Slope (%)	N/A	N/A	DWS Length (in)	N/A
N/A	Landing X Slope (%)	N/A	N/A	DWS Full Width?	N/A
N/A	Landing Curb? (Y/N)	N/A	N/A	DWS Offset (in)	N/A
N/A	Shared Landing?	N/A			
N/A	Gutter Ponding?	N/A	N/A	Gutter Slope (%)	N/A
N/A	Gutter Lip Ht (in)	N/A	N/A	Gutter X Slope (%)	N/A
N/A	Painted X Walk1?	No	N/A	Painted X Walk2?	N/A
	X Walk 1 Direction	To E		X Walk 2 Direction	N/A
	X Walk 1 Width (in)	N/A		X Walk 2 Width (in)	N/A
	X Walk 1 Slope (%)	7.1		X Walk 2 Slope (%)	N/A
	X Walk 1 X Slope (%)	0.7		X Walk 2 X Slope (%)	N/A

N/A	Ramp inside XWalk1?	N/A	N/A	Ramp inside XWalk2?	N/A
	Road Slope (%)	0.7		Clear Space?	N/A
	Road X Slope (%)	7.1	N/A	Clear Space to XWalk (in)	N/A
N/A	Any Obstructions?	N/A	N/A	Storm Grate/Utility Hazard?	N/A
	Obstruction Type			Storm Grate/Utility Type	
		N/A			N/A
			Yes	Surface Condition? (G/P)	Good
			N/A	Curb Slope (%)	2.7

**Remove & Replace Curb Ramp With Two New Directional Ramps or Equivalent.**

**R304.5.1, R304.5.3**

Total Cost: \$ 3200.00
