# Access Compliance Report

## Public Rights-of-Way

### (Curb Ramps)

Intersection ID: 8515	Main Street: ATANDO_AV	Cross Street: STATESVILLE_AV	Location: SW
ADA ID: 38DBB881A516	Ramp Type: Perp	Initial Pass/Fail: Fail	Overall Compliance: No
			Severity Score: 21.25

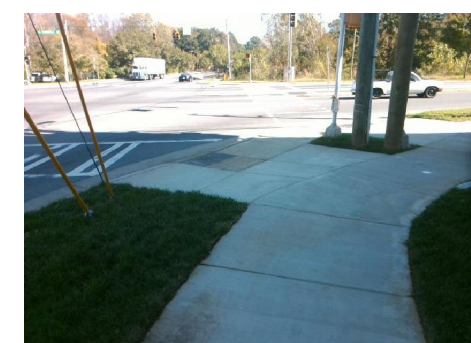
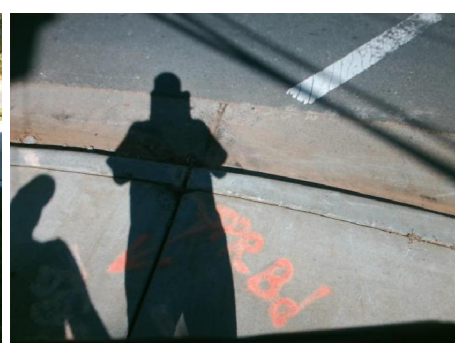
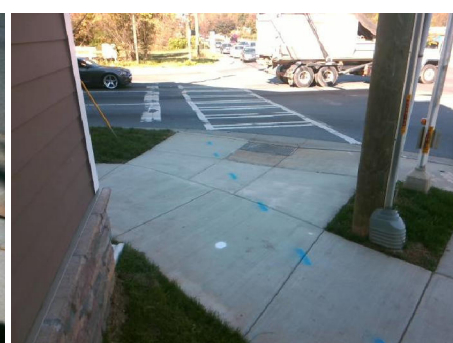
Possible Solutions:		Compliance	Description	Data	Compliance	Description	Data
	Remove & Replace Entire Ramp.		N/A	Ramp Length (in)	113.0	No	Ramp Slope (%)	8.6
			No	Ramp Width (in)	37.5	Yes	Ramp XSlope (%)	0.8
			N/A	Flare Type LT	N/A	N/A	Flare Type RT	N/A
			N/A	Flare Slope LT (%)	N/A	N/A	Flare Slope RT (%)	N/A
			N/A	Flare Traversable LT?	N/A	N/A	Flare Traversable RT?	N/A
			N/A	Landing Length (in)	N/A	N/A	DWS Provided?	N/A
			N/A	Landing Width (in)	N/A	N/A	DWS Contrast?	N/A
			N/A	Landing Slope (%)	N/A	N/A	DWS Length (in)	N/A
			N/A	Landing X Slope (%)	N/A	N/A	DWS Full Width?	N/A
Surveyor Notes:		N/A	N/A	Landing Curb? (Y/N)	N/A	N/A	DWS Offset (in)	N/A
PROW/ADA:		Not Found, R304.5.1, R304.2.2	N/A	Shared Landing?	N/A	N/A	Gutter Slope (%)	N/A
			N/A	Gutter Ponding?	N/A	N/A	Gutter X Slope (%)	N/A
			N/A	Gutter Lip Ht (in)	N/A	N/A	Painted X Walk2?	N/A

N/A	Painted X Walk1?	Yes	N/A	X Walk 2 Direction	N/A
				X Walk 1 Direction	To N		X Walk 2 Width (in)	N/A
			N/A	X Walk 1 Width (in)	112.0	N/A	X Walk 2 Slope (%)	N/A
				X Walk 1 Slope (%)	3.4		X Walk 2 X Slope (%)	N/A
				X Walk 1 X Slope (%)	1.8		Ramp inside XWalk2?	N/A
			N/A	Ramp inside XWalk1?	Yes	N/A	Clear Space?	N/A
				Road Slope (%)	N/A	N/A	Clear Space to XWalk (in)	N/A
				Road X Slope (%)	N/A	N/A	Storm Grate/Utility Hazard?	N/A
			N/A	Any Obstructions?	N/A	N/A	Storm Grate/Utility Type	
				Obstruction Type				
						N/A		N/A
						Yes	Surface Condition? (G/P)	Good
Total Cost:		\$ 1850.00
