# Access Compliance Report

## Public Rights-of-Way

### (Curb Ramps)

Intersection ID: 12011	Main Street: E_16TH_ST	Cross Street: HARRILL_ST	Location:	S
ADA ID: 38E5B2EBBBE8	Ramp Type: BlendTrans1	Initial Pass/Fail: Fail	Overall Compliance: No	Severity Score: 60

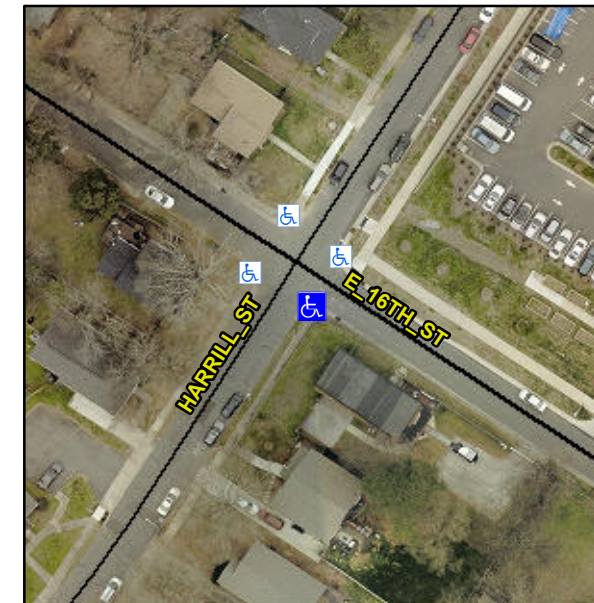
**Not Found, R304.5.1, R304.5.3**

Compliance	Description	Data	Compliance	Description	Data
N/A	Ramp Length (in)	48.0	Yes	BlendTrans Slope (%)	2.7
No	Ramp Width (in)	29.0	No	BlendTrans XSlope (%)	7.9
N/A	Flare Type LT	N/A	N/A	Flare Type RT	N/A
N/A	Flare Slope LT (%)	N/A	N/A	Flare Slope RT (%)	N/A
N/A	Flare Traversable LT?	N/A	N/A	Flare Traversable RT?	N/A
N/A	Landing Length (in)	N/A	N/A	DWS Provided?	N/A
N/A	Landing Width (in)	N/A	N/A	DWS Contrast?	N/A
N/A	Landing Slope (%)	N/A	N/A	DWS Length (in)	N/A
N/A	Landing X Slope (%)	N/A	N/A	DWS Full Width?	N/A
N/A	Landing Curb? (Y/N)	N/A	N/A	DWS Offset (in)	N/A
N/A	Shared Landing?	N/A			
N/A	Gutter Ponding?	N/A	N/A	Gutter Slope (%)	N/A
N/A	Gutter Lip Ht (in)	N/A	N/A	Gutter X Slope (%)	N/A
N/A	Painted X Walk1?	No	N/A	Painted X Walk2?	No
	X Walk 1 Direction	To NE		X Walk 2 Direction	To NW
	X Walk 1 Width (in)	N/A		X Walk 2 Width (in)	N/A
	X Walk 1 Slope (%)	3.5		X Walk 2 Slope (%)	4.0
	X Walk 1 X Slope (%)	3.5		X Walk 2 X Slope (%)	6.3

N/A	Ramp inside XWalk1?	N/A	N/A	Ramp inside XWalk2?	N/A
	Road Slope (%)	5.4		Clear Space?	N/A
	Road X Slope (%)	1.7	N/A	Clear Space to XWalk (in)	N/A
N/A	Any Obstructions?	N/A	N/A	Storm Grate/Utility Hazard?	N/A
	Obstruction Type			Storm Grate/Utility Type	
		N/A			N/A
			Yes	Surface Condition? (G/P)	Good
			No	Curb Slope (%)	22.2

**Remove & Replace Curb Ramp With Two New Directional Ramps or Equivalent.**
