## **Access Compliance Report Public Rights-of-Way** (Curb Ramps)

Intersection ID: 3947 Main Street: COPPERPLATE RD Cross Street: FOUNTAINGROVE DR Location: Ε **Overall Compliance: No Severity Score:** 72.5 ADA ID: 38F2C120875E Ramp Type: Perp Initial Pass/Fail: Fail

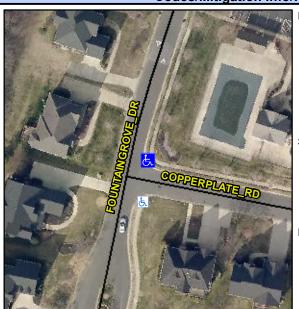
COPPERPLATE RD Street 1 Name Stop Condition-Street 2 StopSign N/A Street 2 Name Stop Condition-Street 1 N/A Possible Solutions: Compliance Description N/A Remove & Replace Entire Ramp. Surveyor Notes: N/A PROW/ADA: R304.5.1, R304.2.2, R304.5.3
