Access Compliance Report

Public Rights-of-Way

(Curb Ramps)

Intersection ID: 13359	Main Street: BARRINGER_DR	Cross Street: S_I-77_RA	Location: SE
ADA ID: 3906B695F00C	Ramp Type: PerpDiag	Initial Pass/Fail: Fail	Overall Compliance: No
Codes/Mitigation Info/Possible Solution		Field Measurements/Component Compliance

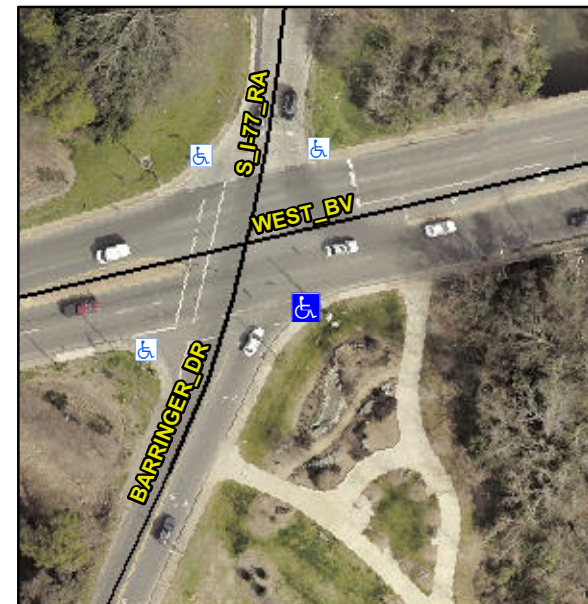
Not Found, R304.2.2, R304.5.3

Compliance	Description	Data	Compliance	Description	Data
N/A	Ramp Length (in)	48.0	No	Ramp Slope (%)	8.6
Yes	Ramp Width (in)	52.5	No	Ramp XSlope (%)	3.9
N/A	Flare Type LT	N/A	N/A	Flare Type RT	N/A
N/A	Flare Slope LT (%)	N/A	N/A	Flare Slope RT (%)	N/A
N/A	Flare Traversable LT?	N/A	N/A	Flare Traversable RT?	N/A
N/A	Landing Length (in)	N/A	N/A	DWS Provided?	N/A
N/A	Landing Width (in)	N/A	N/A	DWS Contrast?	N/A
N/A	Landing Slope (%)	N/A	N/A	DWS Length (in)	N/A
N/A	Landing X Slope (%)	N/A	N/A	DWS Full Width?	N/A
N/A	Landing Curb? (Y/N)	N/A	N/A	DWS Offset (in)	N/A
N/A	Shared Landing?	N/A			
N/A	Gutter Ponding?	N/A	N/A	Gutter Slope (%)	N/A
N/A	Gutter Lip Ht (in)	N/A	N/A	Gutter X Slope (%)	N/A
N/A	Painted X Walk1?	No	N/A	Painted X Walk2?	Yes
	X Walk 1 Direction	To N		X Walk 2 Direction	To W
N/A	X Walk 1 Width (in)	N/A	N/A	X Walk 2 Width (in)	109.0
	X Walk 1 Slope (%)	2.6		X Walk 2 Slope (%)	4.3
	X Walk 1 X Slope (%)	3.4		X Walk 2 X Slope (%)	4.1

N/A	Ramp inside XWalk1?	N/A	N/A	Ramp inside XWalk2?	Yes
	Road Slope (%)	1.6	N/A	Clear Space?	N/A
	Road X Slope (%)	3.0	N/A	Clear Space to XWalk (in)	N/A
N/A	Any Obstructions?	N/A	N/A	Storm Grate/Utility Hazard?	N/A
	Obstruction Type			Storm Grate/Utility Type	
		N/A			N/A
		Yes		Surface Condition? (G/P)	Good

Possible Solutions:

Remove & Replace Curb Ramp With Two New Directional Ramps or Equivalent.
