Access Compliance Report

Public Rights-of-Way

(Curb Ramps)

Intersection ID: 53635	Main Street: NEWBURY GROVE ST	Cross Street: TREMONT RIDGE CT	Location: NE
ADA ID: 390C91578492	Ramp Type: PerpDiag	Initial Pass/Fail: Fail	Overall Compliance: No
Severity Score: 37.5			
Codes/Mitigation Info/Possible Solution		Field Measurements/Component Compliance

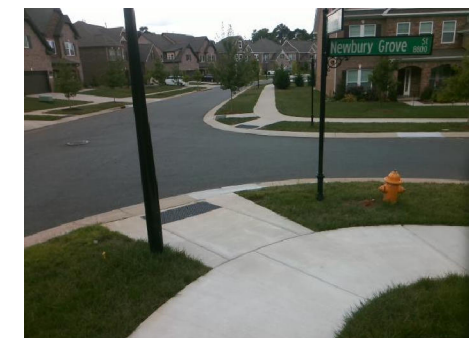
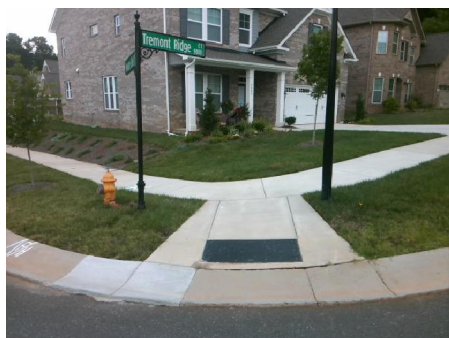
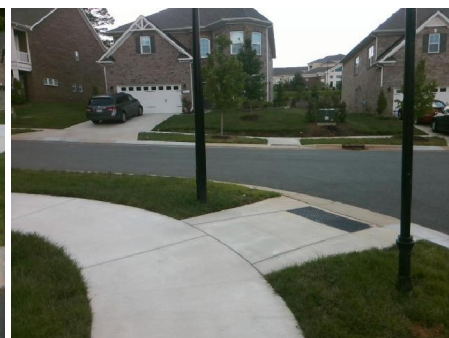
Not Found, R304.2.2, R304.5.3

Compliance	Description	Data	Compliance	Description	Data
N/A	Ramp Length (in)	96.0	No	Ramp Slope (%)	9.1
Yes	Ramp Width (in)	48.0	No	Ramp XSlope (%)	9.6
N/A	Flare Type LT	N/A	N/A	Flare Type RT	N/A
N/A	Flare Slope LT (%)	N/A	N/A	Flare Slope RT (%)	N/A
N/A	Flare Traversable LT?	N/A	N/A	Flare Traversable RT?	N/A
N/A	Landing Length (in)	N/A	N/A	DWS Provided?	N/A
N/A	Landing Width (in)	N/A	N/A	DWS Contrast?	N/A
N/A	Landing Slope (%)	N/A	N/A	DWS Length (in)	N/A
N/A	Landing X Slope (%)	N/A	N/A	DWS Full Width?	N/A
N/A	Landing Curb? (Y/N)	N/A	N/A	DWS Offset (in)	N/A
N/A	Shared Landing?	N/A			
N/A	Gutter Ponding?	N/A	N/A	Gutter Slope (%)	N/A
N/A	Gutter Lip Ht (in)	1.5	N/A	Gutter X Slope (%)	N/A
N/A	Painted X Walk1?	No	N/A	Painted X Walk2?	No
	X Walk 1 Direction	To SW		X Walk 2 Direction	To SE
N/A	X Walk 1 Width (in)	N/A	N/A	X Walk 2 Width (in)	N/A
	X Walk 1 Slope (%)	1.5		X Walk 2 Slope (%)	7.2
	X Walk 1 X Slope (%)	5.5		X Walk 2 X Slope (%)	7.5

N/A	Ramp inside XWalk1?	N/A	N/A	Ramp inside XWalk2?	N/A
	Road Slope (%)	7.3	N/A	Clear Space?	N/A
	Road X Slope (%)	2.8	N/A	Clear Space to XWalk (in)	N/A
N/A	Any Obstructions?	N/A	N/A	Storm Grate/Utility Hazard?	N/A
	Obstruction Type			Storm Grate/Utility Type	
		N/A			N/A
		Yes		Surface Condition? (G/P)	Good

Remove & Replace Curb Ramp With Two New Directional Ramps or Equivalent.
