# Access Compliance Report

## Public Rights-of-Way

| Intersection ID: 26278 | Main Street: BEVINGTON_PL | Cross Street: WESTBURY_WOODS_DR | Location: SW |
| ADA ID: 392B7A013EA2 | Ramp Type: PerpDiag | Initial Pass/Fail: Fail | Overall Compliance: No |

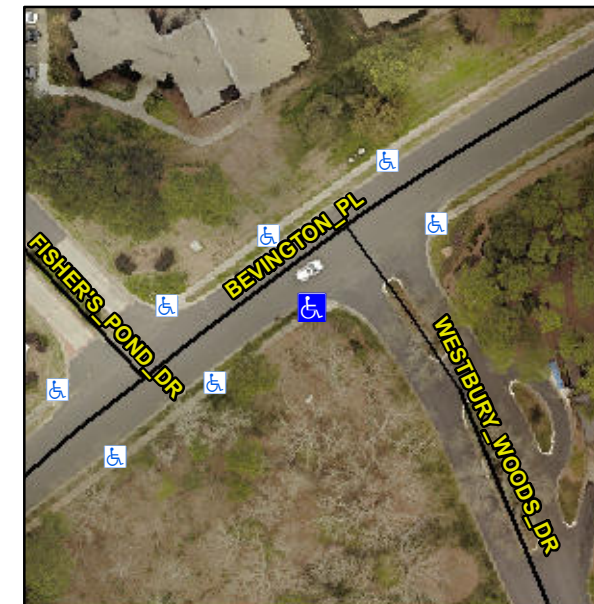
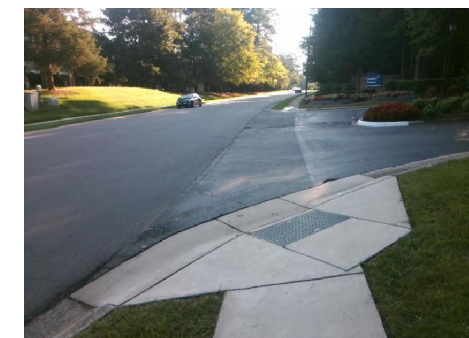
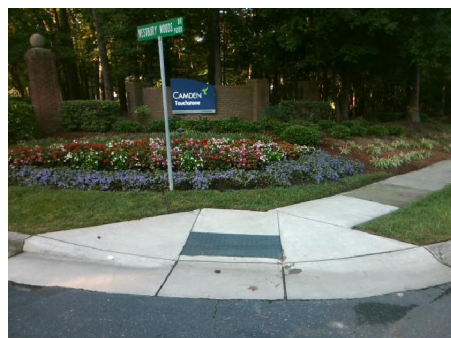
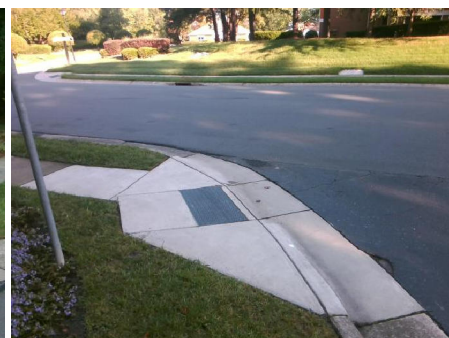
| Severity Score: 22.5 | | | |

**R304.5.1, R304.2.2, R304.5.3**

| Compliance | Description | Data | Compliance | Description | Data |
|---|---|---|---|---|---|
| N/A | Ramp Length (in) | 61.0 | No | Ramp Slope (%) | 11.2 |
| No | Ramp Width (in) | 47.0 | No | Ramp XSlope (%) | 3.7 |

**Remove & Replace Curb Ramp With Two New Directional Ramps or Equivalent.**

Total Cost: \$ 3200.00
