# Access Compliance Report

## Public Rights-of-Way

### (Curb Ramps)

Intersection ID: 26420	Main Street: BEVINGTON_PL	Cross Street: CARSWELL_LN	Location: NE
ADA ID: 3931A7FC863A	Ramp Type: PerpDiag	Initial Pass/Fail: Fail	Overall Compliance: No
		Severity Score: 12.5

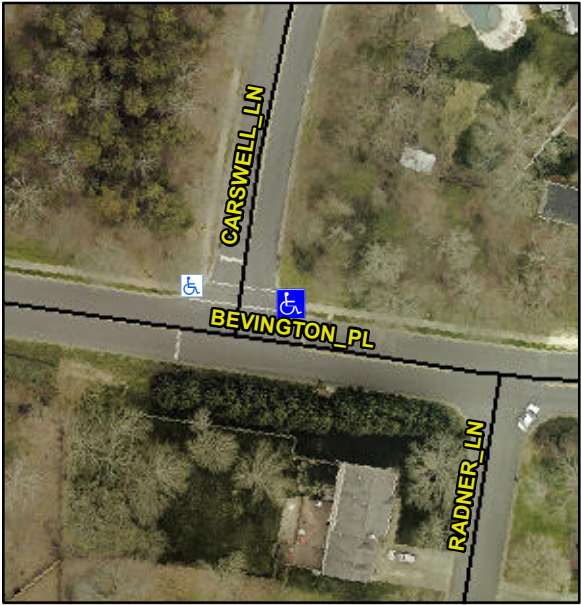
<p>Street 1 Name                      <b>CARSWELL LN</b></p> <p>Stop Condition-Street 2            <b>StopSign</b></p> <p>Street 2 Name                      <b>BEVINGTON PL</b></p> <p>Stop Condition-Street 1            <b>StopSign</b></p>	Possible Solutions:	<b>Remove &amp; Replace Curb Ramp With Two New Directional Ramps or Equivalent.</b>			
	Surveyor Notes:	<b>N/A</b>			
	PROW/ADA:	<b>Not Found, R304.2.2</b>			
	Total Cost:	<b>\$ 3200.00</b>			
			<b>Compliance</b>	<b>Description</b>	<b>Data</b>
			<b>No</b>	Ramp Length (in)	<b>58.0</b>
			<b>Yes</b>	Ramp Width (in)	<b>48.0</b>
			<b>N/A</b>	Flare Type LT	<b>N/A</b>
			<b>N/A</b>	Flare Slope LT (%)	<b>N/A</b>
			<b>N/A</b>	Flare Traversable LT?	<b>N/A</b>
			<b>N/A</b>	Landing Length (in)	<b>N/A</b>
			<b>N/A</b>	Landing Width (in)	<b>N/A</b>
			<b>N/A</b>	Landing Slope (%)	<b>N/A</b>

<b>N/A</b>	Landing X Slope (%)	<b>N/A</b>
			<b>N/A</b>	Landing Curb? (Y/N)	<b>N/A</b>
			<b>N/A</b>	Shared Landing?	<b>N/A</b>
			<b>N/A</b>	Gutter Ponding?	<b>N/A</b>
			<b>N/A</b>	Gutter Lip Ht (in)	<b>N/A</b>
			<b>N/A</b>	Painted X Walk1?	<b>Yes</b>
			<b>To NW</b>	X Walk 1 Direction	<b>To SW</b>
			<b>N/A</b>	X Walk 1 Width (in)	<b>111.0</b>
			<b>1.9</b>	X Walk 1 Slope (%)	<b>N/A</b>
			<b>1.5</b>	X Walk 1 X Slope (%)	<b>1.6</b>
			<b>N/A</b>	Ramp inside XWalk1?	<b>0.1</b>
			<b>Yes</b>	Ramp inside XWalk2?	<b>N/A</b>
			<b>0.8</b>	Road Slope (%)	<b>N/A</b>
			<b>2.8</b>	Road X Slope (%)	<b>N/A</b>
			<b>N/A</b>	Any Obstructions?	<b>N/A</b>
			<b>N/A</b>	Obstruction Type	<b>N/A</b>
			<b>N/A</b>	Clear Space?	<b>N/A</b>
			<b>N/A</b>	Clear Space to XWalk (in)	<b>N/A</b>
			<b>N/A</b>	Storm Grate/Utility Hazard?	<b>N/A</b>
			<b>N/A</b>	Storm Grate/Utility Type	<b>N/A</b>
			<b>Yes</b>	Surface Condition? (G/P)	<b>Good</b>
