Access Compliance Report

Public Rights-of-Way

(Curb Ramps)

Intersection ID: 24153	Main Street: FRESHWELL_RD	Cross Street: STEPHENDALE_DR	Location: SE
ADA ID: 393A518FCF64	Ramp Type: PerpDiag	Initial Pass/Fail: Fail	Overall Compliance: No
Codes/Mitigation Info/Possible Solution		Field Measurements/Component Compliance	
Severity Score: 8.75

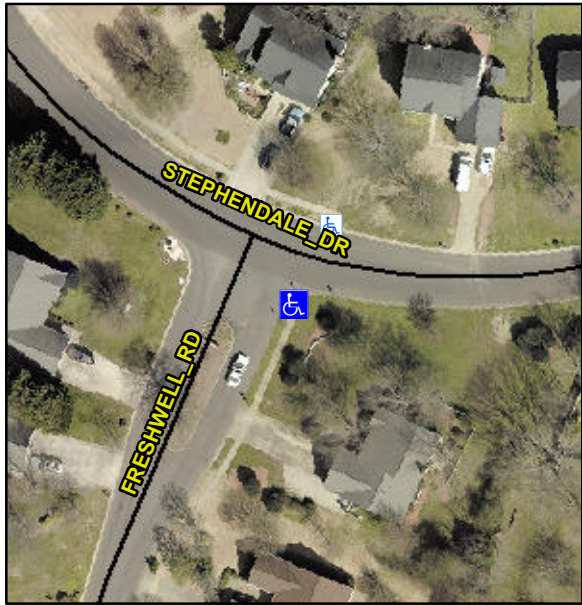
Not Found, R304.5.1

Compliance	Description	Data	Compliance	Description	Data
N/A	Ramp Length (in)	44.0	Yes	Ramp Slope (%)	5.1
No	Ramp Width (in)	47.0	Yes	Ramp XSlope (%)	1.4
N/A	Flare Type LT	N/A	N/A	Flare Type RT	N/A
N/A	Flare Slope LT (%)	N/A	N/A	Flare Slope RT (%)	N/A
N/A	Flare Traversable LT?	N/A	N/A	Flare Traversable RT?	N/A
N/A	Landing Length (in)	N/A	N/A	DWS Provided?	N/A
N/A	Landing Width (in)	N/A	N/A	DWS Contrast?	N/A
N/A	Landing Slope (%)	N/A	N/A	DWS Length (in)	N/A
N/A	Landing X Slope (%)	N/A	N/A	DWS Full Width?	N/A
N/A	Landing Curb? (Y/N)	N/A	N/A	DWS Offset (in)	N/A
N/A	Shared Landing?	N/A			
N/A	Gutter Ponding?	N/A	N/A	Gutter Slope (%)	N/A
N/A	Gutter Lip Ht (in)	N/A	N/A	Gutter X Slope (%)	N/A
N/A	Painted X Walk1?	No	N/A	Painted X Walk2?	No
	X Walk 1 Direction	To NE		X Walk 2 Direction	To NW
N/A	X Walk 1 Width (in)	N/A	N/A	X Walk 2 Width (in)	N/A
	X Walk 1 Slope (%)	0.8		X Walk 2 Slope (%)	2.8
	X Walk 1 X Slope (%)	0.1		X Walk 2 X Slope (%)	2.1

N/A	Ramp inside XWalk1?	N/A	N/A	Ramp inside XWalk2?	N/A
	Road Slope (%)	1.2	N/A	Clear Space?	N/A
	Road X Slope (%)	1.5	N/A	Clear Space to XWalk (in)	N/A
N/A	Any Obstructions?	N/A	N/A	Storm Grate/Utility Hazard?	N/A
	Obstruction Type			Storm Grate/Utility Type	
		N/A			N/A
			Yes	Surface Condition? (G/P)	Good

Remove & Replace Curb Ramp With Two New Directional Ramps or Equivalent.
