Access Compliance Report

Public Rights-of-Way

(Curb Ramps)

| Intersection ID: 7832 | Main Street: FARMFIELD_LN | Cross Street: OLD_CONCORD_RD | Location: W |

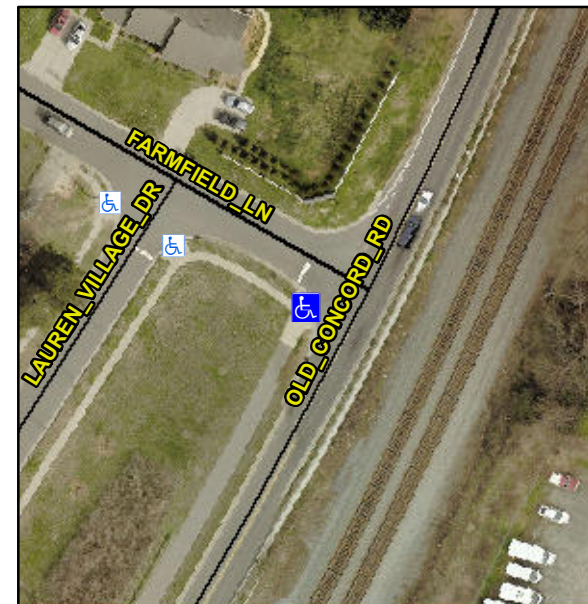
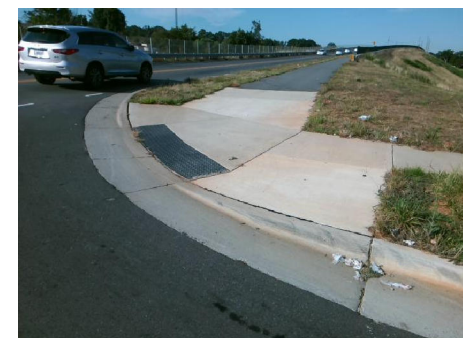
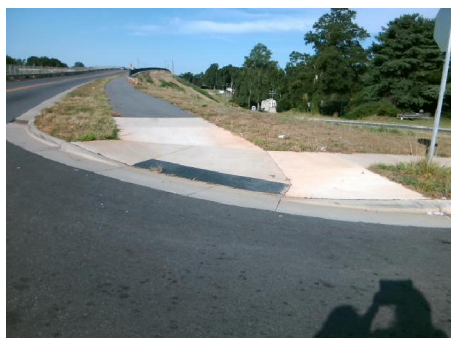
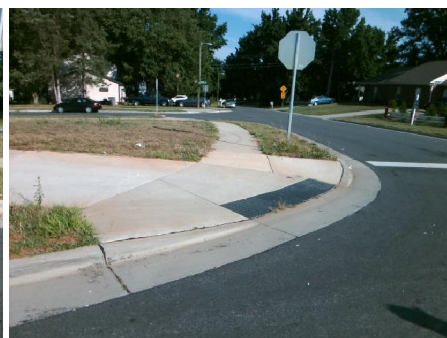
| ADA ID: 393C64FF2C51 | Ramp Type: Perp | Initial Pass/Fail: Fail | Overall Compliance: No |
| Severity Score: 1.25 | | | |

Not Found, R304.5.3

| Compliance | Description | Data | Compliance | Description | Data |
|---|---|---|---|---|---|
| Yes | Ramp Width (in) | 64.0 | No | Ramp XSlope (%) | 4.3 |

Remove & Replace Entire Ramp.
