Access Compliance Report Public Rights-of-Way (Curb Ramps)

Intersection ID: 12027 Main Street: S_SUMMIT_AV Cross Street: W_MOREHEAD_ST Location: NE ADA ID: 3957A78F445D Ramp Type: Perp Initial Pass/Fail: Fail **Overall Compliance: No** Severity Score: 13.75

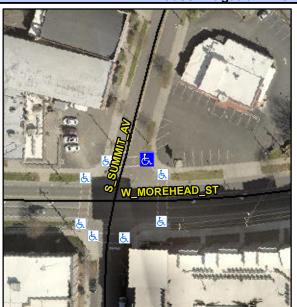
Possible Solution			Field Measurements/Component Compliance						
Possible Solutions:			Comp	liance Description	Data	Comp	Data		
Remove & Replace	Entire Ramp).	N/A	Ramp Length (in)	66.0	No	Ramp Slope (%)	8.4	
·			Yes	Ramp Width (in)	48.0	No	Ramp XSlope (%)	3.0	
			N/A	Flare Type LT	N/A	N/A	Flare Type RT	N/A	
			N/A	Flare Slope LT (%)	N/A	N/A	Flare Slope RT (%)	N/A	
			N/A	Flare Traversable LT?	N/A	N/A	Flare Traversable RT?	N/A	
			N/A	Landing Length (in)	N/A	N/A	DWS Provided?	N/A	
Surveyor Notes:			N/A	Landing Width (in)	N/A	N/A	DWS Contrast?	N/A	
N/A			N/A	Landing Slope (%)	N/A	N/A	DWS Length (in)	N/A	
			N/A	Landing X Slope (%)	N/A	N/A	DWS Full Width?	N/A	
			N/A	Landing Curb? (Y/N)	N/A	N/A	DWS Offset (in)	N/A	
			N/A	Shared Landing?	N/A				
PROW/ADA:			N/A	Gutter Ponding?	N/A	N/A	Gutter Slope (%)	N/A	
Not Found, R304.2	.2, R304.5.3		N/A	Gutter Lip Ht (in)	N/A	N/A	Gutter X Slope (%)	N/A	
,	•		N/A	Painted X Walk1?	Yes	N/A	Painted X Walk2?	N/A

X Walk 1 Direction	To W		X Walk 2 Direction	N/A	
			N/A	X Walk 1 Width (in)	104.0	N/A	X Walk 2 Width (in)	N/A	
				X Walk 1 Slope (%)	5.2		X Walk 2 Slope (%)	N/A	
				X Walk 1 X Slope (%)	1.2		X Walk 2 X Slope (%)	N/A	
			N/A	Ramp inside XWalk1?	Yes	N/A	Ramp inside XWalk2?	N/A	
				Road Slope (%)	N/A	N/A	Clear Space?	N/A	
				Road X Slope (%)	N/A	N/A	Clear Space to XWalk (in)	N/A	
			N/A	Any Obstructions?	N/A	N/A	Storm Grate/Utility Hazard?	N/A	
Total Cost:	\$	1850.00		Obstruction Type			Storm Grate/Utility Type		
					N/A			N/A	
						Yes	Surface Condition? (G/P)	Good
