Access Compliance Report

Public Rights-of-Way

(Curb Ramps)

Intersection ID: 29242	Main Street: MALLARD_FOREST_DR	Cross Street: PENSFOLD_DR	Location: SE
ADA ID: 395B1E6DEAB2	Ramp Type: PerpDiag	Initial Pass/Fail: Fail	Overall Compliance: No
Severity Score: 13.75			
Codes/Mitigation Info/Possible Solution		Field Measurements/Component Compliance

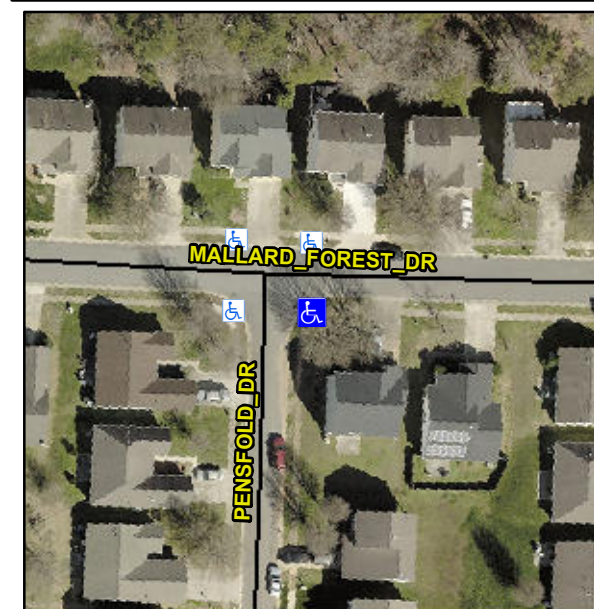
Compliance	Description	Data	Compliance	Description	Data
N/A	Ramp Length (in)	47.0	No	Ramp Slope (%)	8.7
Yes	Ramp Width (in)	50.5	No	Ramp XSlope (%)	3.7
N/A	Flare Type LT	N/A	N/A	Flare Type RT	N/A
N/A	Flare Slope LT (%)	N/A	N/A	Flare Slope RT (%)	N/A
N/A	Flare Traversable LT?	N/A	N/A	Flare Traversable RT?	N/A
N/A	Landing Length (in)	N/A	N/A	DWS Provided?	N/A
N/A	Landing Width (in)	N/A	N/A	DWS Contrast?	N/A
N/A	Landing Slope (%)	N/A	N/A	DWS Length (in)	N/A
N/A	Landing X Slope (%)	N/A	N/A	DWS Full Width?	N/A
N/A	Landing Curb? (Y/N)	N/A	N/A	DWS Offset (in)	N/A
N/A	Shared Landing?	N/A			
N/A	Gutter Ponding?	N/A	N/A	Gutter Slope (%)	N/A
N/A	Gutter Lip Ht (in)	N/A	N/A	Gutter X Slope (%)	N/A
N/A	Painted X Walk1?	No	N/A	Painted X Walk2?	No
	X Walk 1 Direction	To N		X Walk 2 Direction	To W
N/A	X Walk 1 Width (in)	N/A	N/A	X Walk 2 Width (in)	N/A
	X Walk 1 Slope (%)	0.5		X Walk 2 Slope (%)	0.5
	X Walk 1 X Slope (%)	3.8		X Walk 2 X Slope (%)	6.7

N/A	Ramp inside XWalk1?	N/A	N/A	Ramp inside XWalk2?	N/A
	Road Slope (%)	6.1	N/A	Clear Space?	N/A
	Road X Slope (%)	3.8	N/A	Clear Space to XWalk (in)	N/A
N/A	Any Obstructions?	N/A	N/A	Storm Grate/Utility Hazard?	N/A
	Obstruction Type			Storm Grate/Utility Type	
		N/A			N/A
			Yes	Surface Condition? (G/P)	Good

Possible Solutions:

Remove & Replace Curb Ramp With Two New Directional Ramps or Equivalent.
