Access Compliance Report

Public Rights-of-Way

(Curb Ramps)

Intersection ID: 21209	Main Street: GALLERIA_BV	Cross Street: SARDIS_RD_NORTH	Location: S
ADA ID: 39656BD74C06	Ramp Type: Perp	Initial Pass/Fail: Fail	Overall Compliance: No
Severity Score: 22.5			
Codes/Mitigation Info/Possible Solution		Field Measurements/Component Compliance

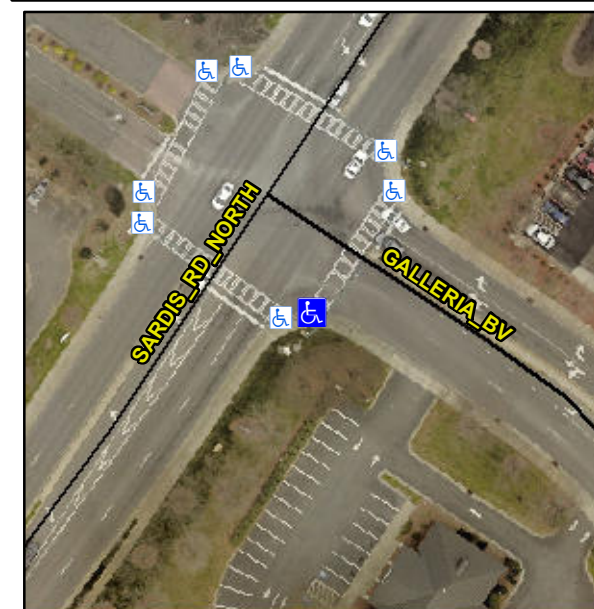
Not Found, R304.5.1, R304.2.2, R304.5.3

Compliance	Description	Data	Compliance	Description	Data
N/A	Ramp Length (in)	71.0	No	Ramp Slope (%)	9.8
No	Ramp Width (in)	40.0	No	Ramp XSlope (%)	3.9
N/A	Flare Type LT	N/A	N/A	Flare Type RT	N/A
N/A	Flare Slope LT (%)	N/A	N/A	Flare Slope RT (%)	N/A
N/A	Flare Traversable LT?	N/A	N/A	Flare Traversable RT?	N/A
N/A	Landing Length (in)	N/A	N/A	DWS Provided?	N/A
N/A	Landing Width (in)	N/A	N/A	DWS Contrast?	N/A
N/A	Landing Slope (%)	N/A	N/A	DWS Length (in)	N/A
N/A	Landing X Slope (%)	N/A	N/A	DWS Full Width?	N/A
N/A	Landing Curb? (Y/N)	N/A	N/A	DWS Offset (in)	N/A
N/A	Shared Landing?	N/A			
N/A	Gutter Ponding?	N/A	N/A	Gutter Slope (%)	N/A
N/A	Gutter Lip Ht (in)	N/A	N/A	Gutter X Slope (%)	N/A
N/A	Painted X Walk1?	Yes	N/A	Painted X Walk2?	N/A
	X Walk 1 Direction	To NE		X Walk 2 Direction	N/A
N/A	X Walk 1 Width (in)	98.0	N/A	X Walk 2 Width (in)	N/A
	X Walk 1 Slope (%)	3.4		X Walk 2 Slope (%)	N/A
	X Walk 1 X Slope (%)	3.2		X Walk 2 X Slope (%)	N/A

N/A	Ramp inside XWalk1?	Yes	N/A	Ramp inside XWalk2?	N/A
	Road Slope (%)	N/A	N/A	Clear Space?	N/A
	Road X Slope (%)	N/A	N/A	Clear Space to XWalk (in)	N/A
N/A	Any Obstructions?	N/A	N/A	Storm Grate/Utility Hazard?	N/A
	Obstruction Type			Storm Grate/Utility Type	
		N/A			N/A
			Yes	Surface Condition? (G/P)	Good

Possible Solutions:

Remove & Replace Entire Ramp.
