Access Compliance Report

Public Rights-of-Way

(Curb Ramps)

Intersection ID: 14710	Main Street: LYNDHURST_AV	Cross Street: MCDONALD_AV	Location: E
ADA ID: 3971F8286729	Ramp Type: Directional1	Initial Pass/Fail: Fail	Overall Compliance: No
Severity Score: 13.75			
Codes/Mitigation Info/Possible Solution		Field Measurements/Component Compliance

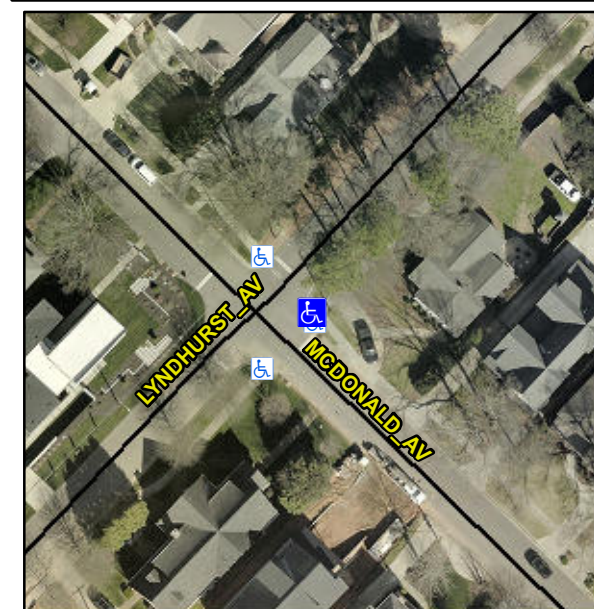
Compliance	Description	Data	Compliance	Description	Data
N/A	Ramp Length (in)	140.5	N/A	Grade Break?	N/A
Yes	Ramp Width (in)	54.0	N/A	Grade Break Slope (%)	0.0
No	Ramp Slope (%)	10.6	N/A	Grade Break XSlope (%)	0.0
No	Ramp XSlope (%)	5.0			
N/A	Flare Type LT	N/A	N/A	Flare Type RT	N/A
N/A	Flare Slope LT (%)	N/A	N/A	Flare Slope RT (%)	0.0
N/A	Flare Traversable LT?	N/A	N/A	Flare Traversable RT?	N/A
N/A	Landing Length (in)	0.0	N/A	DWS Provided?	N/A
N/A	Landing Width (in)	0.0	N/A	DWS Contrast?	N/A
N/A	Landing Slope (%)	0.0	N/A	DWS Length (in)	N/A
N/A	Landing X Slope (%)	0.0	N/A	DWS Full Width?	N/A
N/A	Landing Curb? (Y/N)	N/A	N/A	DWS Offset LT (in)	N/A
N/A	Shared Landing?	N/A	N/A	DWS Offset RT (in)	N/A
N/A	Gutter Ponding?	0.0	N/A	Gutter Slope (%)	N/A
N/A	Gutter Lip Ht (in)	1.5	N/A	Gutter X Slope (%)	N/A
N/A	Painted X Walk1?	No		Road Slope (%)	3.6
	X Walk 1 Direction	To NW		Road X Slope (%)	4.0
	X Walk 1 Width (in)	N/A		Clear Space?	N/A

X Walk 1 Slope (%)	3.6	N/A	Clear Space to XWalk (in)	N/A
	X Walk 1 X Slope (%)	4.0	N/A	Storm Grate/Utility Hazard?	N/A
N/A	Ramp inside XWalk1?	N/A		Storm Grate/Utility Type	
N/A	Any Obstructions?	N/A			N/A
	Obstruction Type		Yes	Surface Condition? (G/P)	Good
			N/A	Curb Slope (%)	12.1

Possible Solutions:

Remove & Replace Entire Ramp.

R304.2.2, R304.5.3
