Access Compliance Report

Public Rights-of-Way

(Curb Ramps)

Intersection ID: 45976	Main Street: NIKKI_COLE_DR	Cross Street: JAMES_RD	Location: SW
ADA ID: 398C476D0C1E	Ramp Type: Perp	Initial Pass/Fail: Fail	Overall Compliance: No
		Severity Score: 22.5

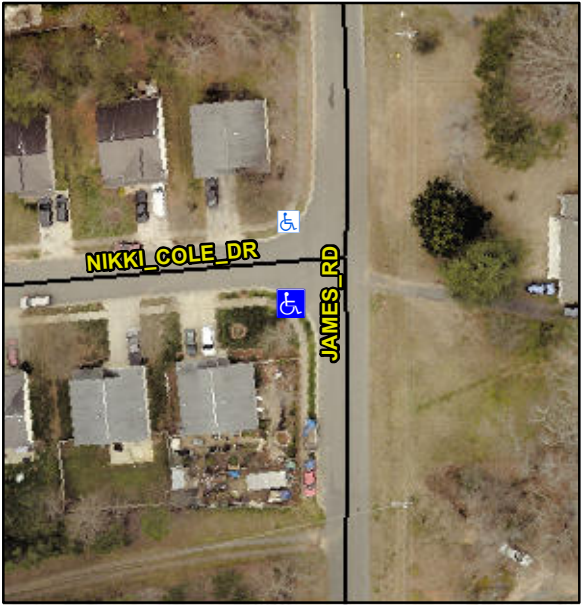
Possible Solutions:		Compliance	Description	Data
	Remove & Replace Entire Ramp.		No	Ramp Length (in)	47.5
			No	Ramp Width (in)	44.0
			N/A	Flare Type LT	N/A
			N/A	Flare Slope LT (%)	N/A
			N/A	Flare Traversable LT?	N/A
			N/A	Landing Length (in)	N/A
			N/A	Landing Width (in)	N/A
			N/A	Landing Slope (%)	N/A
			N/A	Landing X Slope (%)	N/A
<p>Surveyor Notes:</p> <p>N/A</p> <p>PROW/ADA:</p> <p>Not Found, R304.5.1, R304.2.2, R304.5.3</p>			N/A	Flare Type RT	N/A
			N/A	Flare Slope RT (%)	N/A
			N/A	Flare Traversable RT?	N/A
			N/A	DWS Provided?	N/A
			N/A	DWS Contrast?	N/A
			N/A	DWS Length (in)	N/A
			N/A	DWS Full Width?	N/A
			N/A	DWS Offset (in)	N/A
			N/A	Gutter Ponding?	N/A
			N/A	Gutter Lip Ht (in)	N/A
<p>Total Cost:</p> <p>\$ 1850.00</p>			No	Painted X Walk1?	N/A
			To N	X Walk 1 Direction	N/A
			N/A	X Walk 1 Width (in)	N/A

2.7	X Walk 1 Slope (%)	N/A
			5.5	X Walk 1 X Slope (%)	N/A
			N/A	Ramp inside XWalk1?	N/A
			N/A	Road Slope (%)	N/A
			N/A	Road X Slope (%)	N/A
			N/A	Any Obstructions?	N/A
			N/A	Obstruction Type	N/A
			N/A	Clear Space?	N/A
			N/A	Clear Space to XWalk (in)	N/A
			N/A	Storm Grate/Utility Hazard?	N/A
			N/A	Storm Grate/Utility Type	N/A
			Yes	Surface Condition? (G/P)	Good
