# Access Compliance Report

## Public Rights-of-Way

### (Curb Ramps)

Intersection ID: 44488	Main Street: CHALKSTONE_RD	Cross Street: FINN_HALL_AV	Location: S
ADA ID: 39955A54921C	Ramp Type: BlendTrans1	Initial Pass/Fail: Fail	Overall Compliance: No
		Severity Score: 10

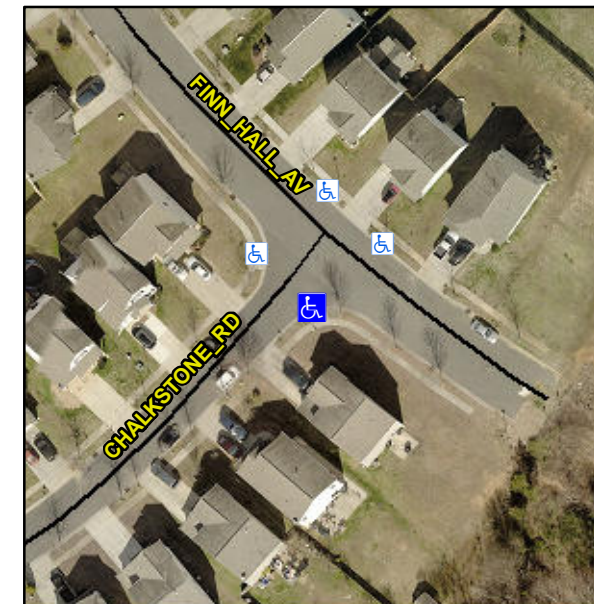
**Not Found, R304.5.1, R304.5.3**

Compliance	Description	Data	Compliance	Description	Data
N/A	Ramp Length (in)	52.0	Yes	BlendTrans Slope (%)	2.6
No	Ramp Width (in)	46.5	No	BlendTrans XSlope (%)	3.3
N/A	Flare Type LT	N/A	N/A	Flare Type RT	N/A
N/A	Flare Slope LT (%)	N/A	N/A	Flare Slope RT (%)	N/A
N/A	Flare Traversable LT?	N/A	N/A	Flare Traversable RT?	N/A
N/A	Landing Length (in)	N/A	N/A	DWS Provided?	N/A
N/A	Landing Width (in)	N/A	N/A	DWS Contrast?	N/A
N/A	Landing Slope (%)	N/A	N/A	DWS Length (in)	N/A
N/A	Landing X Slope (%)	N/A	N/A	DWS Full Width?	N/A
N/A	Landing Curb? (Y/N)	N/A	N/A	DWS Offset (in)	N/A
N/A	Shared Landing?	N/A			
N/A	Gutter Ponding?	N/A	N/A	Gutter Slope (%)	N/A
N/A	Gutter Lip Ht (in)	N/A	N/A	Gutter X Slope (%)	N/A
N/A	Painted X Walk1?	No	N/A	Painted X Walk2?	No
	X Walk 1 Direction	To NE		X Walk 2 Direction	To NW
	X Walk 1 Width (in)	N/A		X Walk 2 Width (in)	N/A
	X Walk 1 Slope (%)	0.4		X Walk 2 Slope (%)	1.1
	X Walk 1 X Slope (%)	1.4		X Walk 2 X Slope (%)	3.3

N/A	Ramp inside XWalk1?	N/A	N/A	Ramp inside XWalk2?	N/A
	Road Slope (%)	3.2		Clear Space?	N/A
	Road X Slope (%)	3.6	N/A	Clear Space to XWalk (in)	N/A
N/A	Any Obstructions?	N/A	N/A	Storm Grate/Utility Hazard?	N/A
	Obstruction Type			Storm Grate/Utility Type	
		N/A			N/A
			Yes	Surface Condition? (G/P)	Good
			No	Curb Slope (%)	8.3

**Remove & Replace Curb Ramp With Two New Directional Ramps or Equivalent.**
