| Intersection ID: 19485 | Main Street: MONIQUE_LN | Cross Street: PARK_RD | Location: | SE |
| ADA ID: 39997A809A09 | Ramp Type: PerpDiag | Initial Pass/Fail: Fail | Overall Compliance: No | Severity Score: 12.5 |

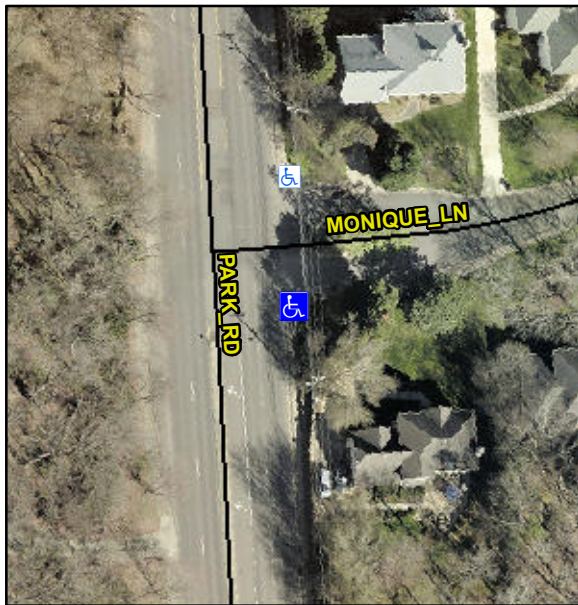
**Not Found, R304.2.2**

| Compliance | Description | Data | Compliance | Description | Data |
|---|---|---|---|---|---|
| N/A | Ramp Length (in) | 61.0 | No | Ramp Slope (%) | 8.8 |
| Yes | Ramp Width (in) | 48.0 | Yes | Ramp XSlope (%) | 0.8 |

### Possible Solutions:

**Remove & Replace Curb Ramp With Two New Directional Ramps or Equivalent.**
