# Access Compliance Report

## Public Rights-of-Way

### (Curb Ramps)

Intersection ID: N/A	Main Street: PINEVILLE-MATTHEWS_RD	Cross Street: CHALLIS_FARM_RD	Location: NW
ADA ID: 399E97739859	Ramp Type: PerpDiag	Initial Pass/Fail: Fail	Overall Compliance: No
			Severity Score: 13.75

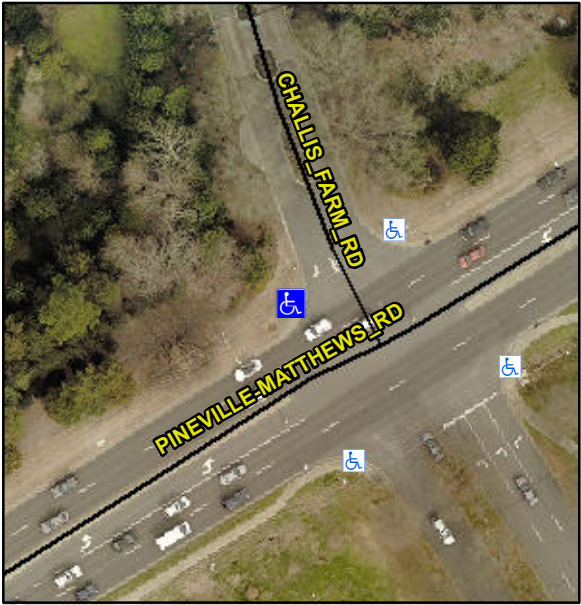
Compliance	Description	Data	Compliance	Description	Data
N/A	Ramp Length (in)	47.0	No	Ramp Slope (%)	10.6
Yes	Ramp Width (in)	48.0	No	Ramp XSlope (%)	4.6
N/A	Flare Type LT	N/A	N/A	Flare Type RT	N/A
N/A	Flare Slope LT (%)	N/A	N/A	Flare Slope RT (%)	N/A
N/A	Flare Traversable LT?	N/A	N/A	Flare Traversable RT?	N/A
N/A	Landing Length (in)	N/A	N/A	DWS Provided?	N/A
N/A	Landing Width (in)	N/A	N/A	DWS Contrast?	N/A
N/A	Landing Slope (%)	N/A	N/A	DWS Length (in)	N/A
N/A	Landing X Slope (%)	N/A	N/A	DWS Full Width?	N/A
N/A	Landing Curb? (Y/N)	N/A	N/A	DWS Offset (in)	N/A
N/A	Shared Landing?	N/A			
N/A	Gutter Ponding?	N/A	N/A	Gutter Slope (%)	N/A
N/A	Gutter Lip Ht (in)	N/A	N/A	Gutter X Slope (%)	N/A
N/A	Painted X Walk1?	No	N/A	Painted X Walk2?	No
	X Walk 1 Direction	To S		X Walk 2 Direction	To NE
N/A	X Walk 1 Width (in)	N/A	N/A	X Walk 2 Width (in)	N/A
	X Walk 1 Slope (%)	6.1		X Walk 2 Slope (%)	3.2
	X Walk 1 X Slope (%)	3.1		X Walk 2 X Slope (%)	5.5

N/A	Ramp inside XWalk1?	N/A	N/A	Ramp inside XWalk2?	N/A
	Road Slope (%)	3.3	N/A	Clear Space?	N/A
	Road X Slope (%)	6.0	N/A	Clear Space to XWalk (in)	N/A
N/A	Any Obstructions?	N/A	N/A	Storm Grate/Utility Hazard?	N/A
	Obstruction Type			Storm Grate/Utility Type	
		N/A			N/A
			Yes	Surface Condition? (G/P)	Good

Possible Solutions:				
	<b>Remove &amp; Replace Curb Ramp With Two New Directional Ramps or Equivalent.</b>				
	Surveyor Notes:				
	<b>N/A</b>				
	PROW/ADA:				
	<b>Not Found, R304.2.2, R304.5.3</b>				
Street 1 Name	PINEVILLE-MATTHEWS RD				
Stop Condition-Street 2	None				
Street 2 Name	CHALLIS FARM RD				
Stop Condition-Street 1	StopSign				
Total Cost:		\$	3200.00
