# Access Compliance Report

## Public Rights-of-Way

### (Curb Ramps)

Intersection ID: 28611	Main Street: FALCONCREST_DR	Cross Street: KESTRAL_RIDGE_DR	Location: E
ADA ID: 399FB7989196	Ramp Type: PerpDiag	Initial Pass/Fail: Fail	Overall Compliance: No
Codes/Mitigation Info/Possible Solution		Field Measurements/Component Compliance	
Severity Score: 21.25

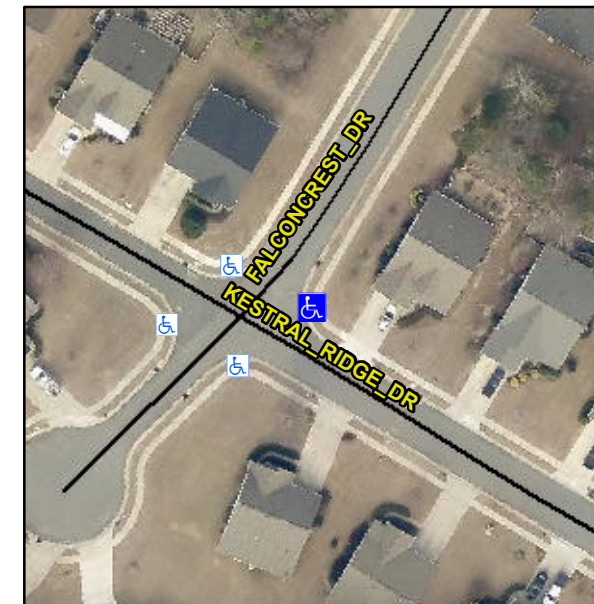
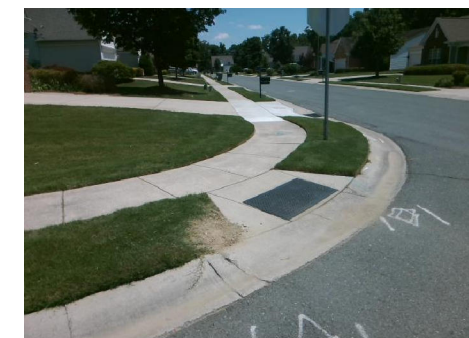
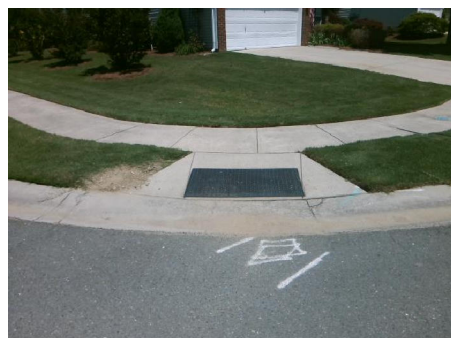
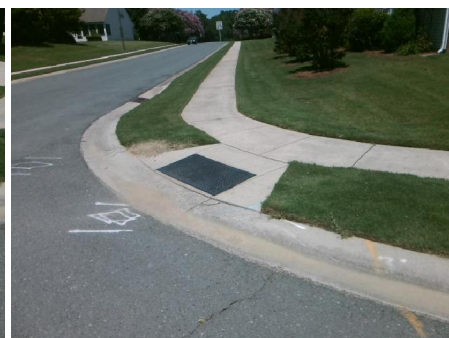
**Not Found, R304.5.1, R304.2.2**

Compliance	Description	Data	Compliance	Description	Data
N/A	Ramp Length (in)	46.0	No	Ramp Slope (%)	9.4
No	Ramp Width (in)	47.0	Yes	Ramp XSlope (%)	0.5
N/A	Flare Type LT	N/A	N/A	Flare Type RT	N/A
N/A	Flare Slope LT (%)	N/A	N/A	Flare Slope RT (%)	N/A
N/A	Flare Traversable LT?	N/A	N/A	Flare Traversable RT?	N/A
N/A	Landing Length (in)	N/A	N/A	DWS Provided?	N/A
N/A	Landing Width (in)	N/A	N/A	DWS Contrast?	N/A
N/A	Landing Slope (%)	N/A	N/A	DWS Length (in)	N/A
N/A	Landing X Slope (%)	N/A	N/A	DWS Full Width?	N/A
N/A	Landing Curb? (Y/N)	N/A	N/A	DWS Offset (in)	N/A
N/A	Shared Landing?	N/A			
N/A	Gutter Ponding?	N/A	N/A	Gutter Slope (%)	N/A
N/A	Gutter Lip Ht (in)	N/A	N/A	Gutter X Slope (%)	N/A
N/A	Painted X Walk1?	No	N/A	Painted X Walk2?	No
	X Walk 1 Direction	To NW		X Walk 2 Direction	To SW
N/A	X Walk 1 Width (in)	N/A	N/A	X Walk 2 Width (in)	N/A
	X Walk 1 Slope (%)	1.0		X Walk 2 Slope (%)	1.6
	X Walk 1 X Slope (%)	1.8		X Walk 2 X Slope (%)	0.5

N/A	Ramp inside XWalk1?	N/A	N/A	Ramp inside XWalk2?	N/A
	Road Slope (%)	0.1	N/A	Clear Space?	N/A
	Road X Slope (%)	1.2	N/A	Clear Space to XWalk (in)	N/A
N/A	Any Obstructions?	N/A	N/A	Storm Grate/Utility Hazard?	N/A
	Obstruction Type			Storm Grate/Utility Type	
		N/A			N/A
			Yes	Surface Condition? (G/P)	Good

**Remove & Replace Curb Ramp With Two New Directional Ramps or Equivalent.**
