Access Compliance Report

Public Rights-of-Way

(Curb Ramps)

Intersection ID: 6465	Main Street: PEACHTREE_RD	Cross Street: OAKDALE_RD	Location: SW
ADA ID: 39A68BBB5C7F	Ramp Type: Perp	Initial Pass/Fail: Fail	Overall Compliance: No
Severity Score: 8.75			
Codes/Mitigation Info/Possible Solution		Field Measurements/Component Compliance

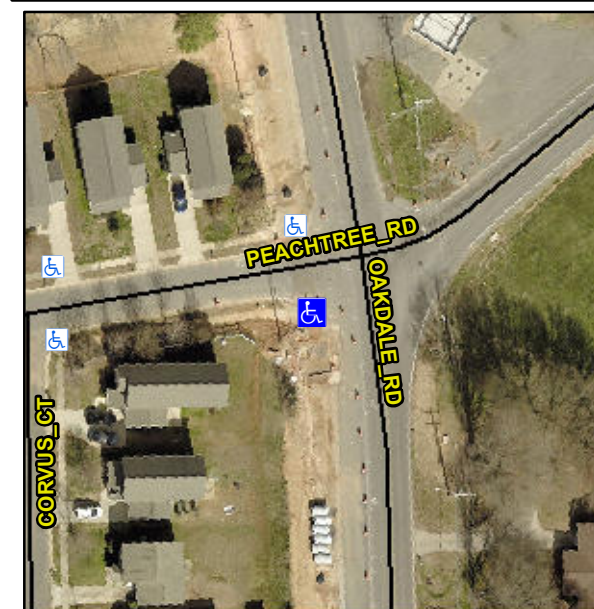
Not Found, R304.5.1

Compliance	Description	Data	Compliance	Description	Data
N/A	Ramp Length (in)	46.0	Yes	Ramp Slope (%)	5.7
No	Ramp Width (in)	41.5	Yes	Ramp XSlope (%)	0.7
N/A	Flare Type LT	N/A	N/A	Flare Type RT	N/A
N/A	Flare Slope LT (%)	N/A	N/A	Flare Slope RT (%)	N/A
N/A	Flare Traversable LT?	N/A	N/A	Flare Traversable RT?	N/A
N/A	Landing Length (in)	N/A	N/A	DWS Provided?	N/A
N/A	Landing Width (in)	N/A	N/A	DWS Contrast?	N/A
N/A	Landing Slope (%)	N/A	N/A	DWS Length (in)	N/A
N/A	Landing X Slope (%)	N/A	N/A	DWS Full Width?	N/A
N/A	Landing Curb? (Y/N)	N/A	N/A	DWS Offset (in)	N/A
N/A	Shared Landing?	N/A			
N/A	Gutter Ponding?	N/A	N/A	Gutter Slope (%)	N/A
N/A	Gutter Lip Ht (in)	N/A	N/A	Gutter X Slope (%)	N/A
N/A	Painted X Walk1?	No	N/A	Painted X Walk2?	N/A
	X Walk 1 Direction	To N		X Walk 2 Direction	N/A
N/A	X Walk 1 Width (in)	N/A	N/A	X Walk 2 Width (in)	N/A
	X Walk 1 Slope (%)	2.6		X Walk 2 Slope (%)	N/A
	X Walk 1 X Slope (%)	3.1		X Walk 2 X Slope (%)	N/A

N/A	Ramp inside XWalk1?	N/A	N/A	Ramp inside XWalk2?	N/A
	Road Slope (%)	N/A	N/A	Clear Space?	N/A
	Road X Slope (%)	N/A	N/A	Clear Space to XWalk (in)	N/A
N/A	Any Obstructions?	N/A	N/A	Storm Grate/Utility Hazard?	N/A
	Obstruction Type			Storm Grate/Utility Type	
		N/A			N/A
			Yes	Surface Condition? (G/P)	Good

Possible Solutions:

Remove & Replace Entire Ramp.
