Access Compliance Report

Public Rights-of-Way

(Curb Ramps)

Intersection ID: 19683	Main Street: CARNEGIE_BV	Cross Street: CONGRESS_ST	Location: SW
ADA ID: 39C808F6A846	Ramp Type: PerpDiag	Initial Pass/Fail: Fail	Overall Compliance: No
Severity Score: 22.5			
Codes/Mitigation Info/Possible Solution		Field Measurements/Component Compliance

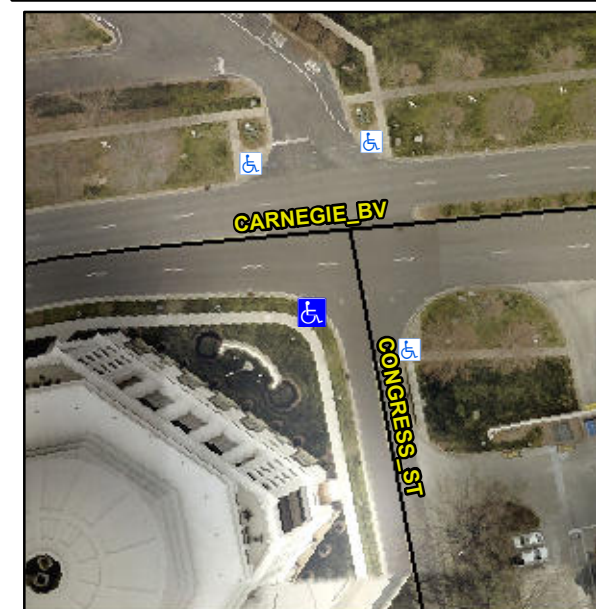
PROW/ADA:

Not Found, R304.5.1, R304.2.2, R304.5.3

Compliance	Description	Data	Compliance	Description	Data
N/A	Ramp Length (in)	97.0	No	Ramp Slope (%)	9.7
No	Ramp Width (in)	47.5	No	Ramp XSlope (%)	2.4
N/A	Flare Type LT	N/A	N/A	Flare Type RT	N/A
N/A	Flare Slope LT (%)	N/A	N/A	Flare Slope RT (%)	N/A
N/A	Flare Traversable LT?	N/A	N/A	Flare Traversable RT?	N/A
N/A	Landing Length (in)	N/A	N/A	DWS Provided?	N/A
N/A	Landing Width (in)	N/A	N/A	DWS Contrast?	N/A
N/A	Landing Slope (%)	N/A	N/A	DWS Length (in)	N/A
N/A	Landing X Slope (%)	N/A	N/A	DWS Full Width?	N/A
N/A	Landing Curb? (Y/N)	N/A	N/A	DWS Offset (in)	N/A
N/A	Shared Landing?	N/A			
N/A	Gutter Ponding?	N/A	N/A	Gutter Slope (%)	N/A
N/A	Gutter Lip Ht (in)	N/A	N/A	Gutter X Slope (%)	N/A
N/A	Painted X Walk1?	No	N/A	Painted X Walk2?	No
	X Walk 1 Direction	To SE		X Walk 2 Direction	To N
N/A	X Walk 1 Width (in)	N/A	N/A	X Walk 2 Width (in)	N/A
	X Walk 1 Slope (%)	2.3		X Walk 2 Slope (%)	1.8
	X Walk 1 X Slope (%)	3.2		X Walk 2 X Slope (%)	1.3

N/A	Ramp inside XWalk1?	N/A	N/A	Ramp inside XWalk2?	N/A
	Road Slope (%)	1.2	N/A	Clear Space?	N/A
	Road X Slope (%)	2.1	N/A	Clear Space to XWalk (in)	N/A
N/A	Any Obstructions?	N/A	N/A	Storm Grate/Utility Hazard?	N/A
	Obstruction Type			Storm Grate/Utility Type	
		N/A			N/A
			Yes	Surface Condition? (G/P)	Good

Possible Solutions:

Remove & Replace Curb Ramp With Two New Directional Ramps or Equivalent.
