Access Compliance Report

Public Rights-of-Way

(Curb Ramps)

Intersection ID: 27236	Main Street: BALLANTYNE CORPORATE PL	Cross Street: BRIXHAM HILL AV	Location: SW
ADA ID: 39CC7EA96B3F	Ramp Type: Perp	Initial Pass/Fail: Fail	Overall Compliance: No
Severity Score: 25			
Codes/Mitigation Info/Possible Solution		Field Measurements/Component Compliance

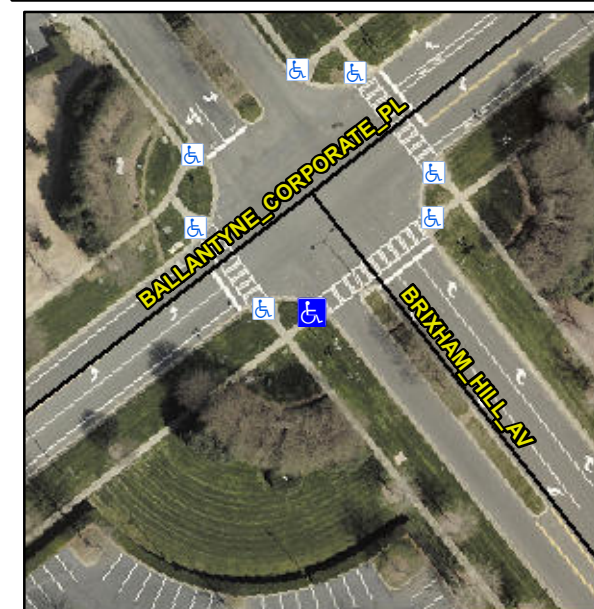
Compliance	Description	Data	Compliance	Description	Data
N/A	Ramp Length (in)	91.0	No	Ramp Slope (%)	13.7
Yes	Ramp Width (in)	48.0	Yes	Ramp XSlope (%)	0.8
N/A	Flare Type LT	N/A	N/A	Flare Type RT	N/A
N/A	Flare Slope LT (%)	N/A	N/A	Flare Slope RT (%)	N/A
N/A	Flare Traversable LT?	N/A	N/A	Flare Traversable RT?	N/A
N/A	Landing Length (in)	N/A	N/A	DWS Provided?	N/A
N/A	Landing Width (in)	N/A	N/A	DWS Contrast?	N/A
N/A	Landing Slope (%)	N/A	N/A	DWS Length (in)	N/A
N/A	Landing X Slope (%)	N/A	N/A	DWS Full Width?	N/A
N/A	Landing Curb? (Y/N)	N/A	N/A	DWS Offset (in)	N/A
N/A	Shared Landing?	N/A			
N/A	Gutter Ponding?	N/A	N/A	Gutter Slope (%)	N/A
N/A	Gutter Lip Ht (in)	N/A	N/A	Gutter X Slope (%)	N/A
N/A	Painted X Walk1?	Yes	N/A	Painted X Walk2?	N/A
	X Walk 1 Direction	To NE		X Walk 2 Direction	N/A
N/A	X Walk 1 Width (in)	111.0	N/A	X Walk 2 Width (in)	N/A
	X Walk 1 Slope (%)	3.0		X Walk 2 Slope (%)	N/A
	X Walk 1 X Slope (%)	1.8		X Walk 2 X Slope (%)	N/A

N/A	Ramp inside XWalk1?	Yes	N/A	Ramp inside XWalk2?	N/A
	Road Slope (%)	N/A	N/A	Clear Space?	N/A
	Road X Slope (%)	N/A	N/A	Clear Space to XWalk (in)	N/A
N/A	Any Obstructions?	N/A	N/A	Storm Grate/Utility Hazard?	N/A
	Obstruction Type			Storm Grate/Utility Type	
		N/A			N/A
			Yes	Surface Condition? (G/P)	Good

Possible Solutions:

Remove & Replace Entire Ramp.

R304.2.2
