Access Compliance Report

Public Rights-of-Way

(Curb Ramps)

| Intersection ID: 43687 | Main Street: PORTSTEWART_LN | Cross Street: TODDINGTON_LN | Location: SE |

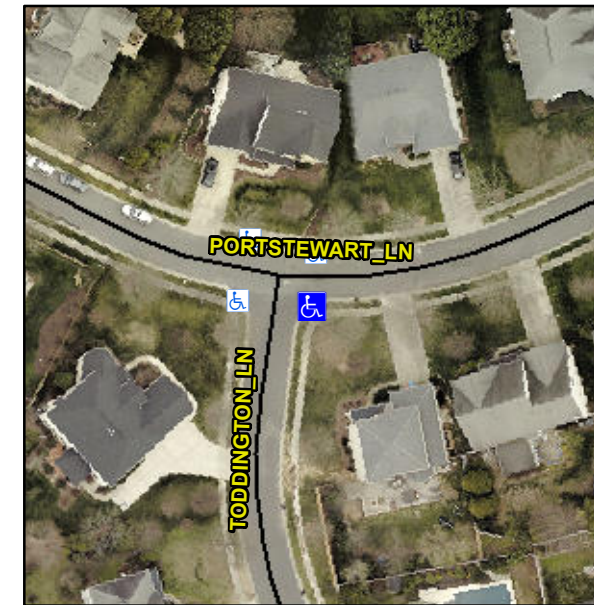
| ADA ID: 39CF1D632BE6 | Ramp Type: PerpDiag | Initial Pass/Fail: Fail | Overall Compliance: No |

Not Found, R304.5.1, R304.5.3

| Compliance | Description | Data | Compliance | Description | Data |
|---|---|---|---|---|---|
| N/A | Ramp Length (in) | 48.0 | Yes | Ramp Slope (%) | 5.2 |
| No | Ramp Width (in) | 39.0 | No | Ramp XSlope (%) | 3.4 |

Remove & Replace Curb Ramp With Two New Directional Ramps or Equivalent.

Total Cost: \$ 3200.00
